Limited Soil Investigation
Skyline College
Slope Erosion (FMC Facility)
Slopes Surrounding FMC Facility
3300 College Drive
San Bruno, California

Prepared For
San Mateo County Community College District
C/O Swinerton Management & Consulting
3300 College Drive, Loma Chica Building
San Bruno, California

File No. 09504-Erosion
September 2009

Subject: Skyline College
Slope Erosion – FMC Facility
3300 College Drive
San Bruno, California
LIMITED SOIL INVESTIGATION

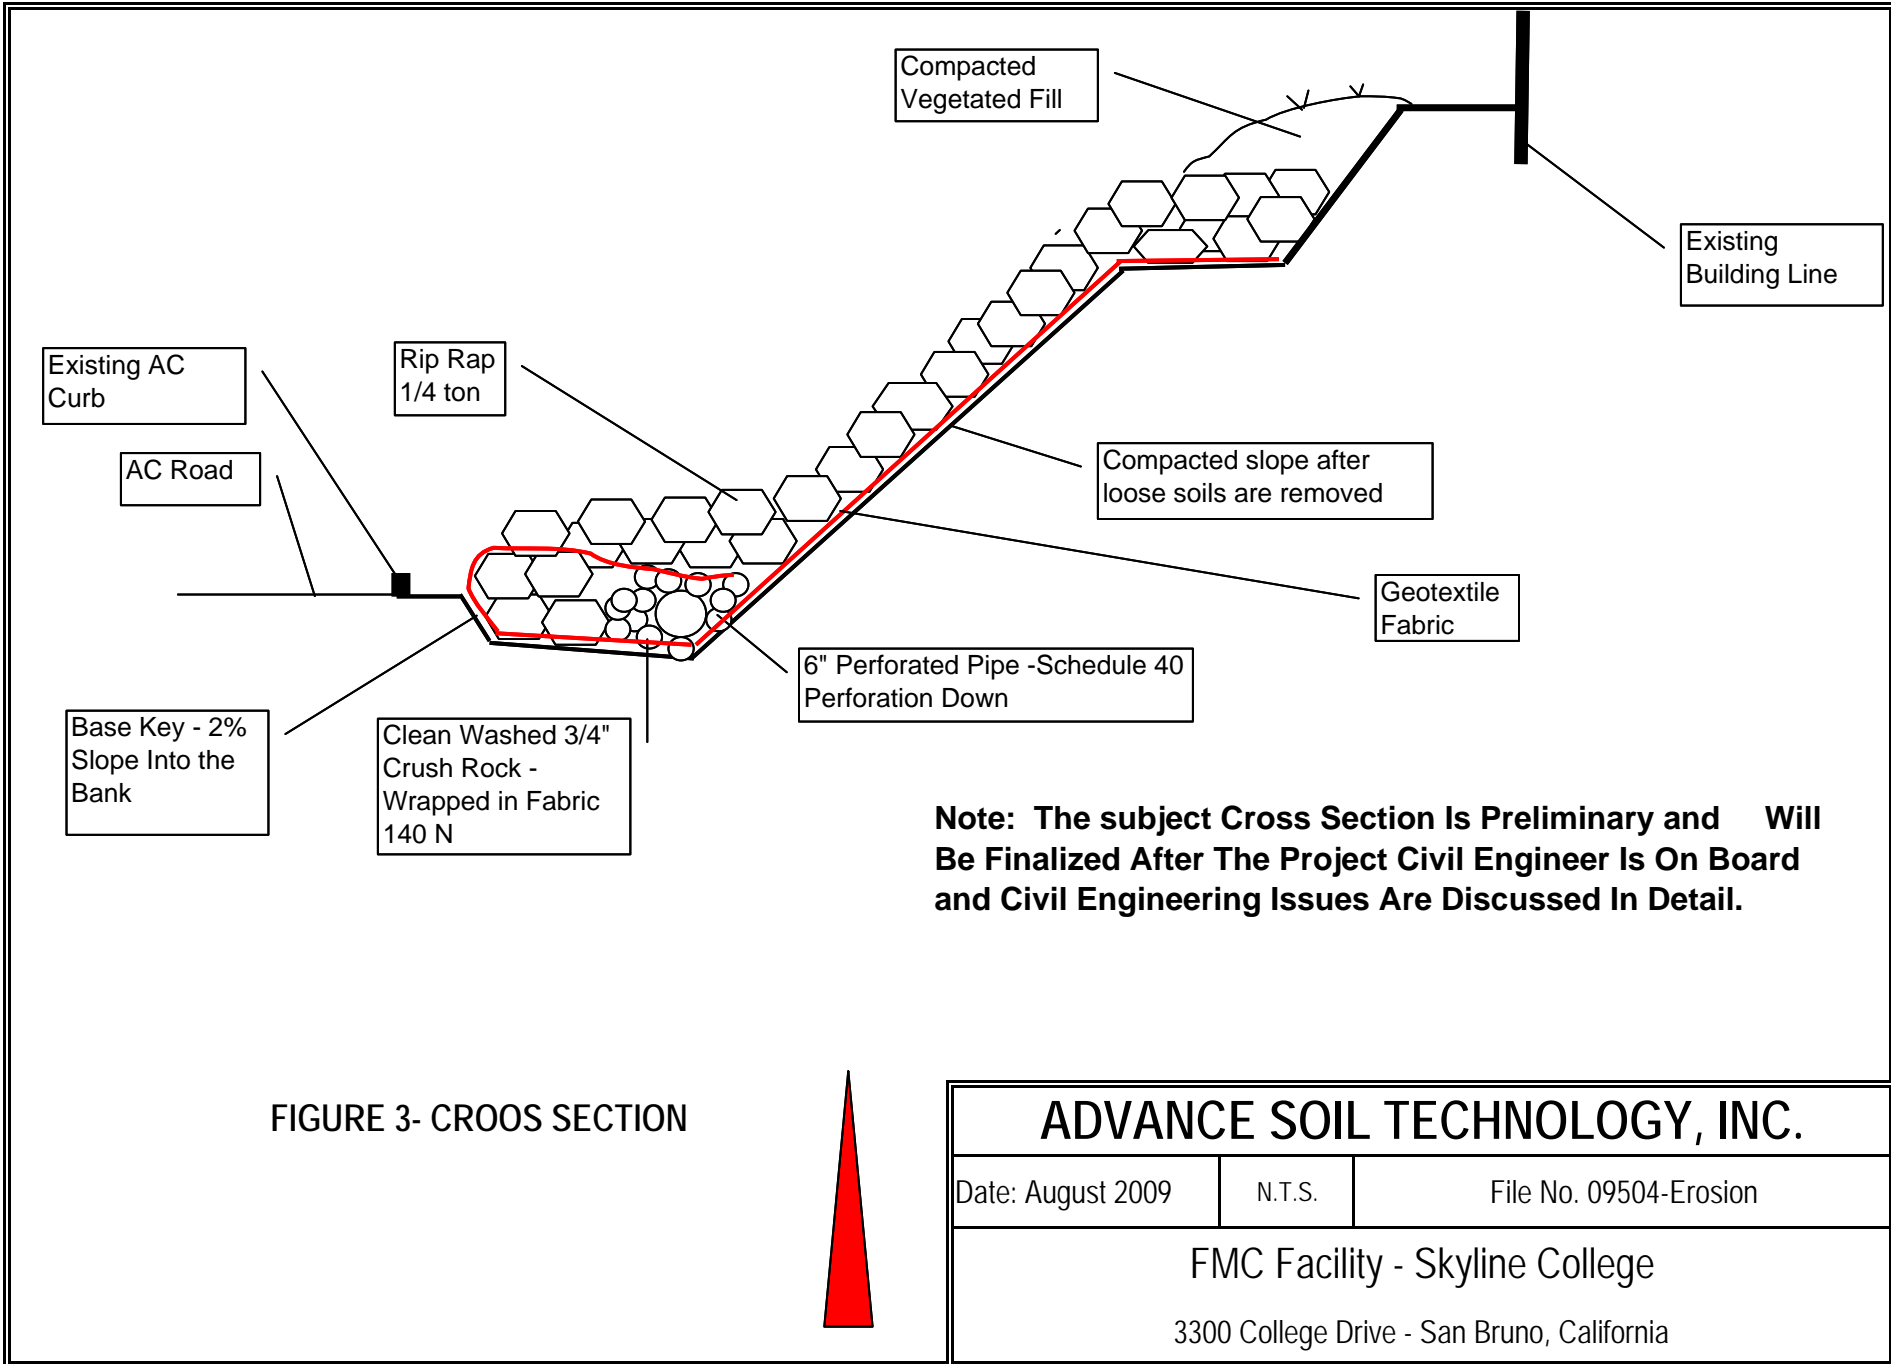
FIGURE 3- CROOS SECTION

Note: The subject Cross Section Is Preliminary and Will Be Finalized After The Project Civil Engineer Is On Board and Civil Engineering Issues Are Discussed In Detail.

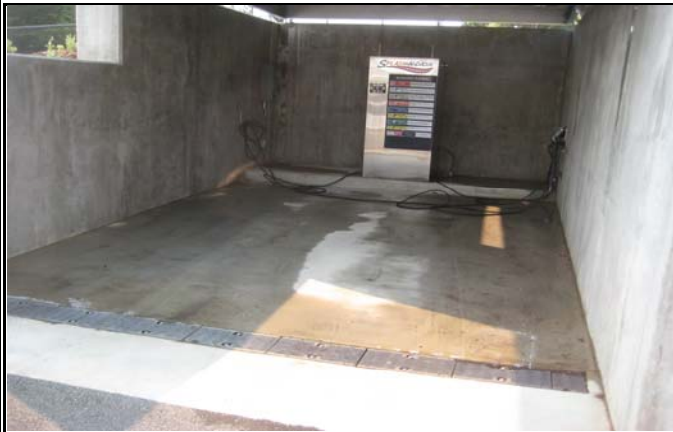
1- Equipment wash area

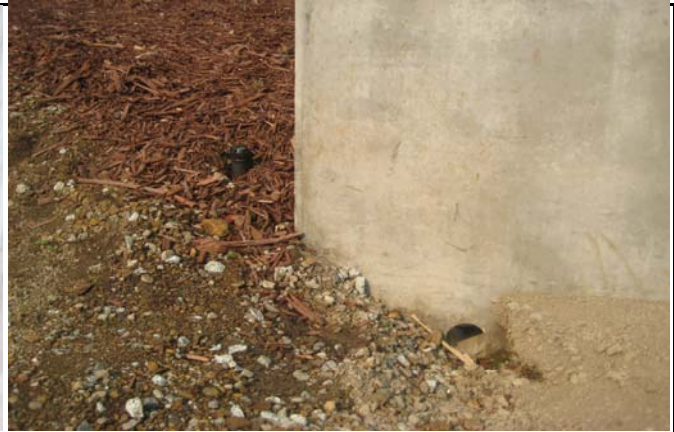
2- Drain from equipment washing area

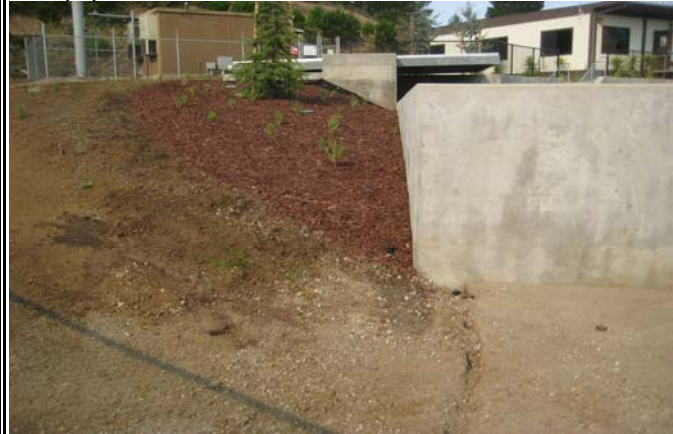
3- Drain outlet (Washing Area) - Soil Erosion

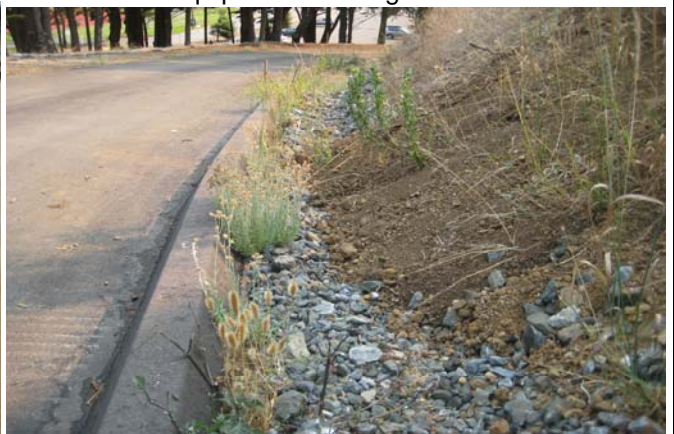
The degree of slope erosion varies from one area to another at the subject property. The slope located to the north of the property facing the roadway (See picture 2) is experiencing a higher degree of erosion. Caving and sloughing of soil has been observed in this area which needs to be addressed immediately. To minimize the erosion in this area, we recommend that the loose and unstable soil from the slope be removed and slope surface shall be compacted / track walked and the area be covered with jute netting / or fabric. A base key shall be installed at the toe and along the entire length of the existing slope. The base key shall be a minimum of three feet wide and shall be excavated a minimum of three feet below the existing or proposed grade, whichever governs. The base key shall be graded inward towards the existing slope with a minimum of 2% grade. A six inch diameter perforated PVC pipe (Schedule 40 or higher) encased in fabric and gravel shall be installed as shown in figure 3. The pipe shall have a minimum of ¼ to ½-inch perforations, placed facing down with a minimum of 2% slope in the direction of the downspout location. The pipe shall be placed on a minimum of (3) inches of ½" to ¾" clean angular gravel at the

4- Soil Erosion - North Side

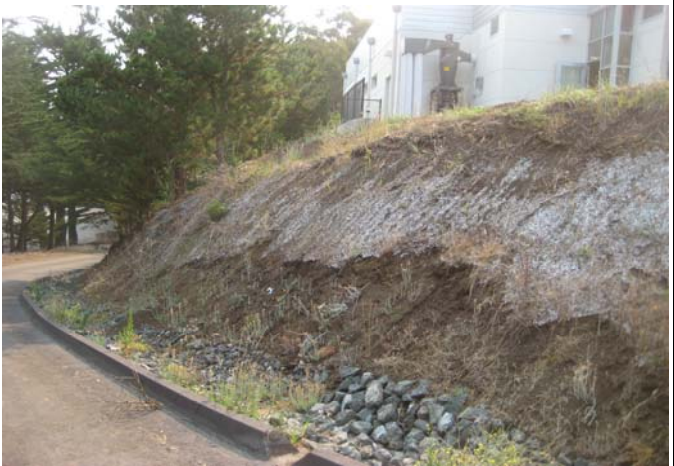
6- Roof drain box - North Slope

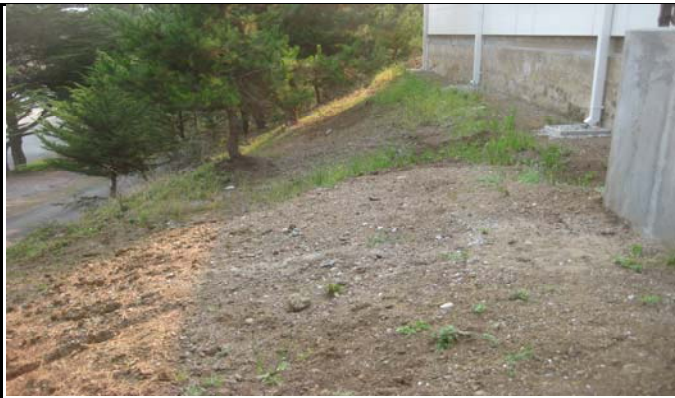
7- Slope to the north

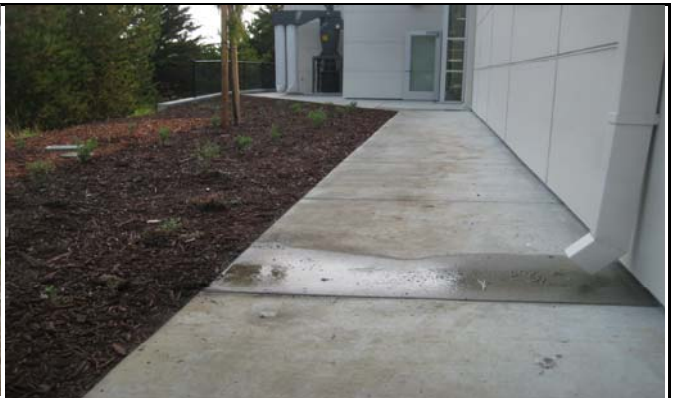
8- Drain from equipment washing area

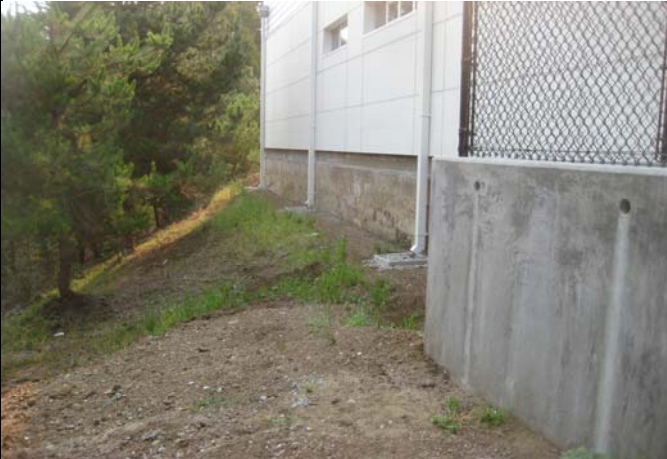
9- Drain outlet (Washing Area) - Soil Erosion

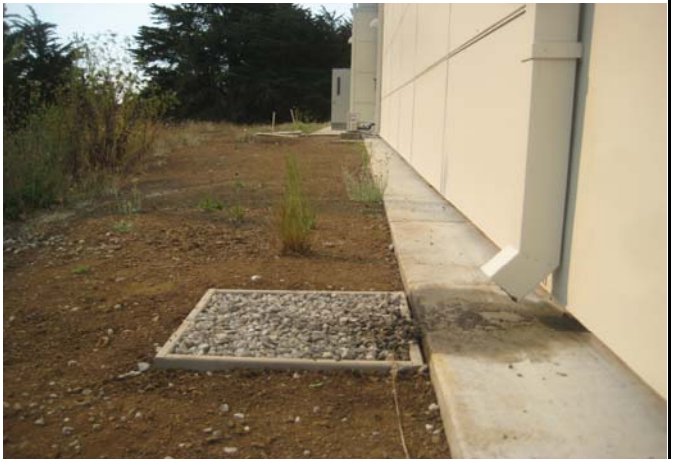
10- Soil Erosion - North Side

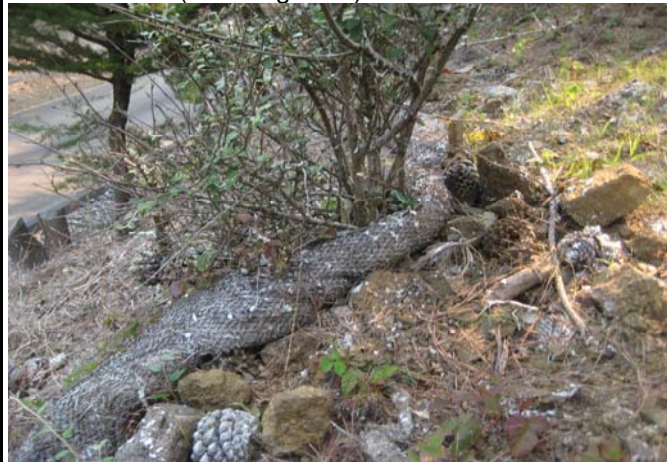
11- Soil Erosion - North Side - Caving

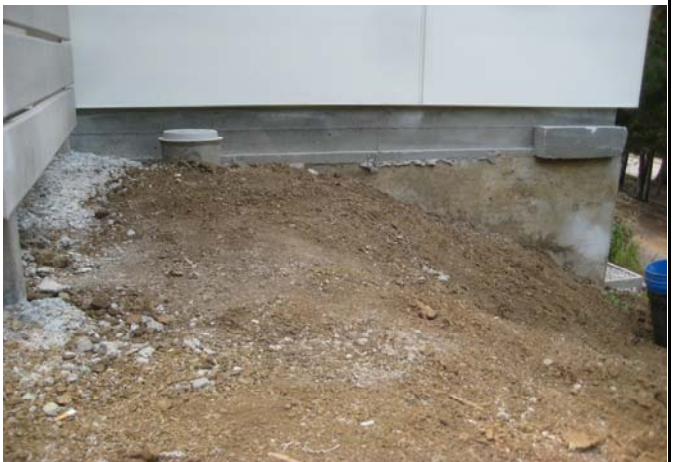
12- Roof drain box - North Slope

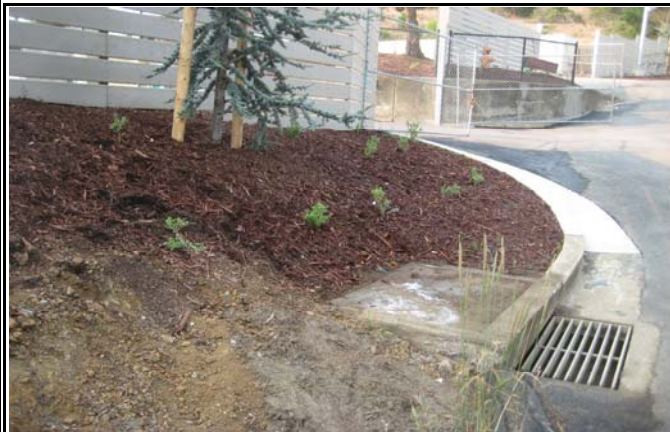
13- Catch Basin On The North Side

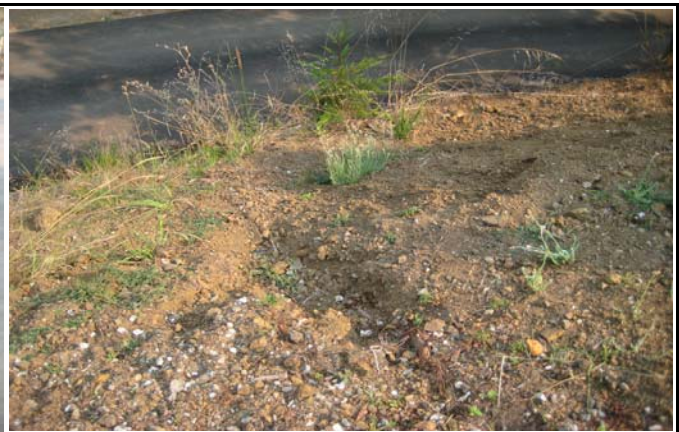
14- Soil erosion on the north slope

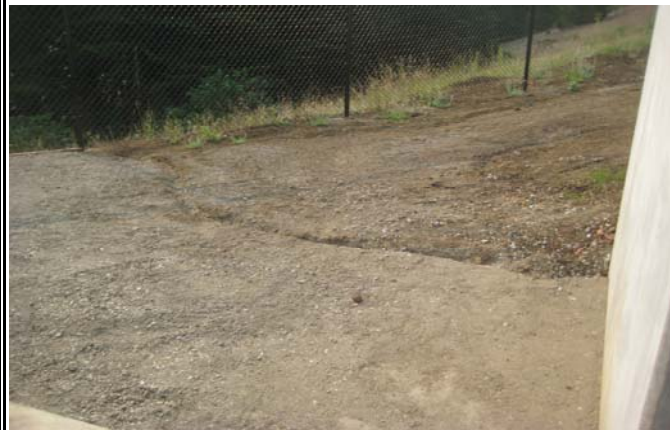
15- Loose and uncompacted soil on the south slope

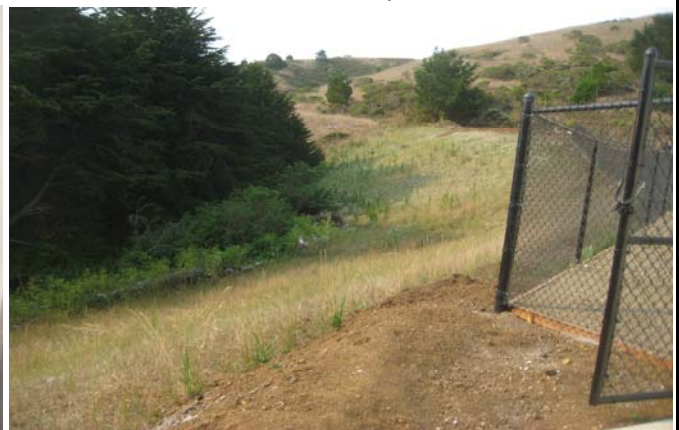
16- Soil erosion-drain outlet - east slope

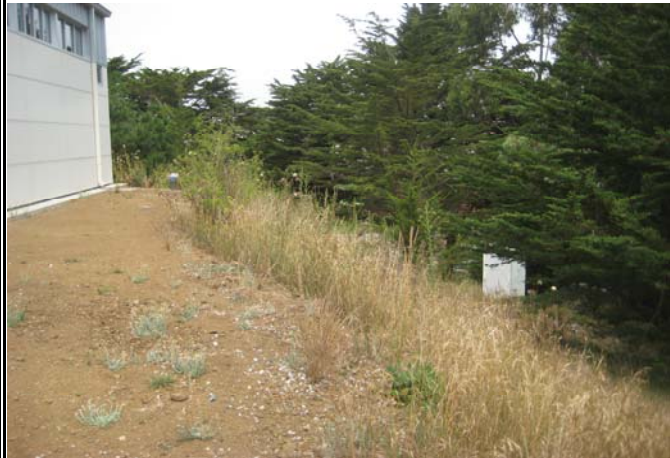
17- Soil erosion - east side

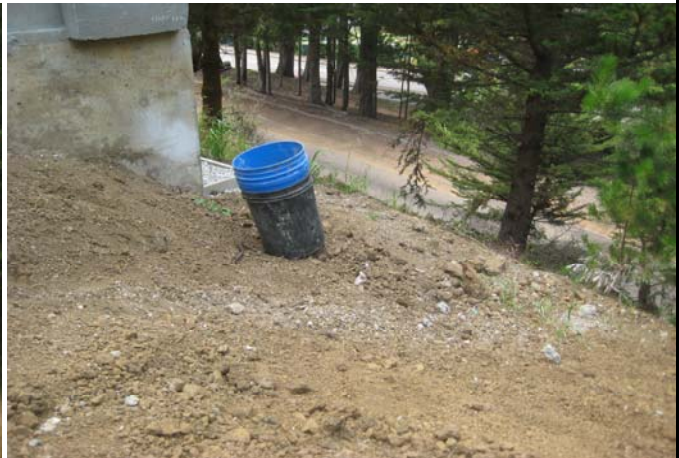
18- loose, uncompacted soil on the north slope

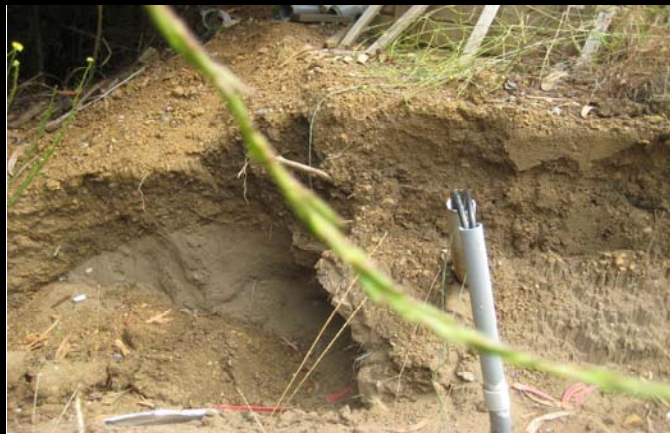
19- Caving of utility trenches - Erosion

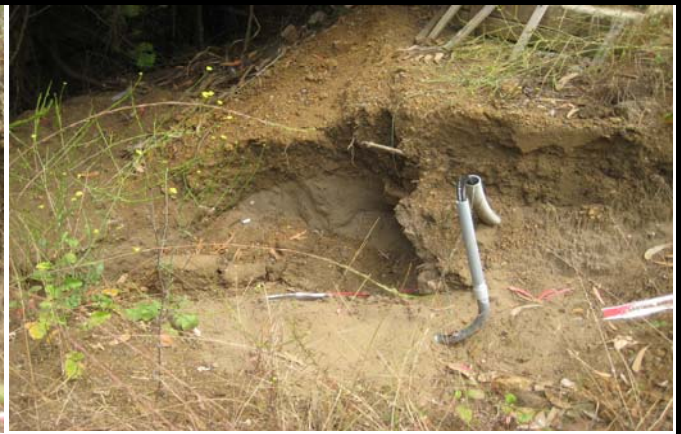
20- Utility trench erosion

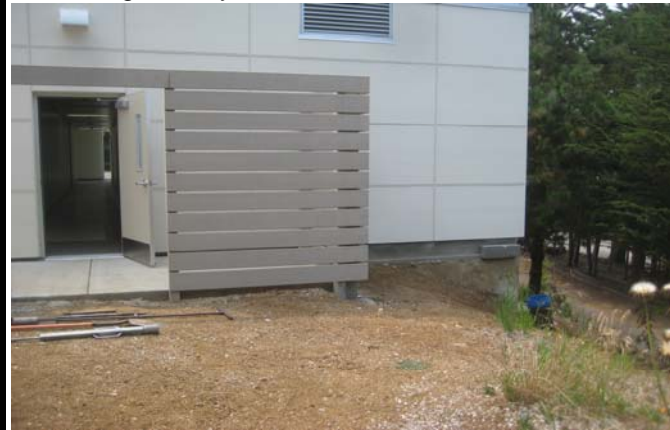
21- Loose soil adjacent to the building

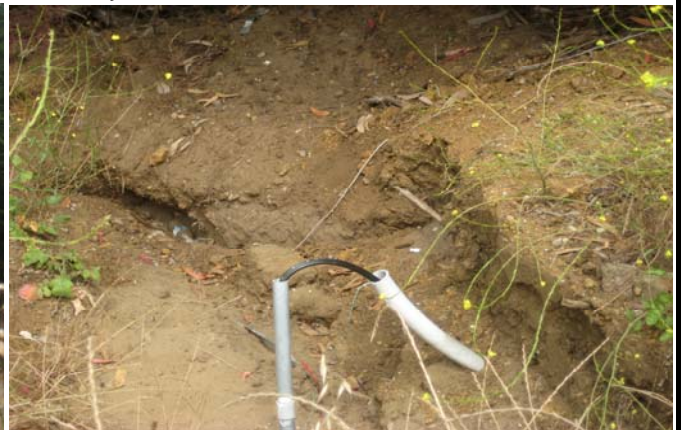
22- Erosion of utility trenches

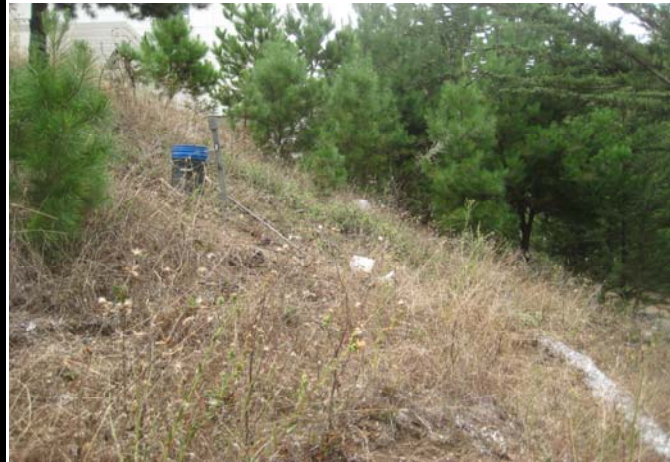
23- Slope erosion on the east

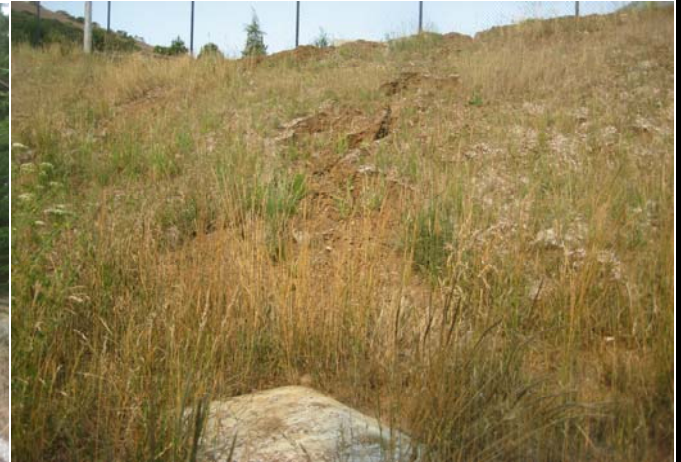
24- Slope erosion south - east of the property
