October 31, 2006
Project No. 401256002

Subject: Asbestos Abatement Specifications, Abatement Drawings, and Associated Tables and Graphics Related to the Planned Abatement Activities at CSM Buildings 10, 11, 12, 14, and 19
San Mateo County Community College District, San Mateo Campus
San Mateo, California

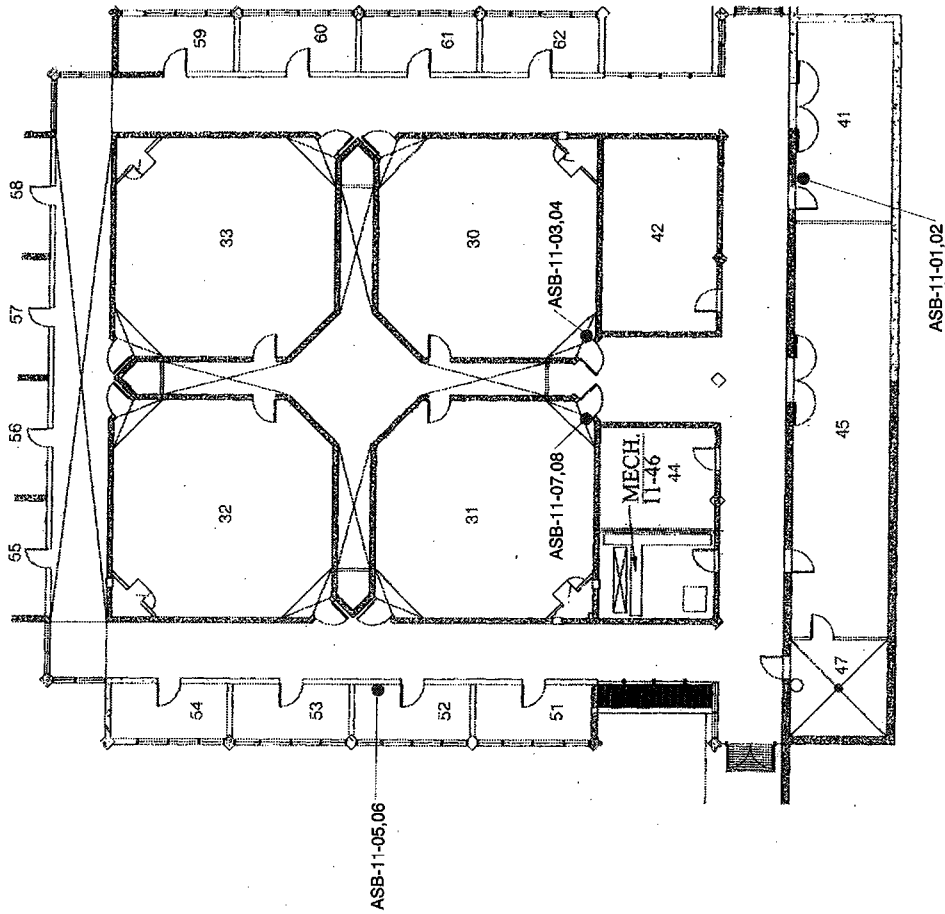
FIGURE 1

ACM SAMPLE LOCATIONS

COLLEGE OF SAN MATEO
CSM-BUILDING 11, GROUND FLOOR
SAN MATEO, CALIFORNIA

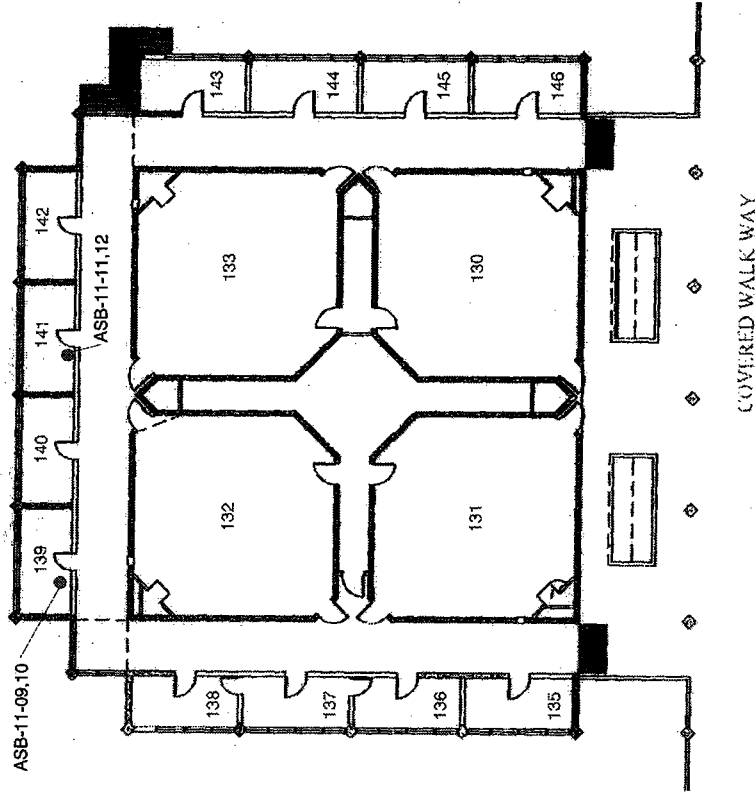
FIGURE 2

ACM SAMPLE LOCATIONS
 COLLEGE OF SAN MATEO
 CSM-BUILDING 11, FIRST FLOOR
 SAN MATEO, CALIFORNIA

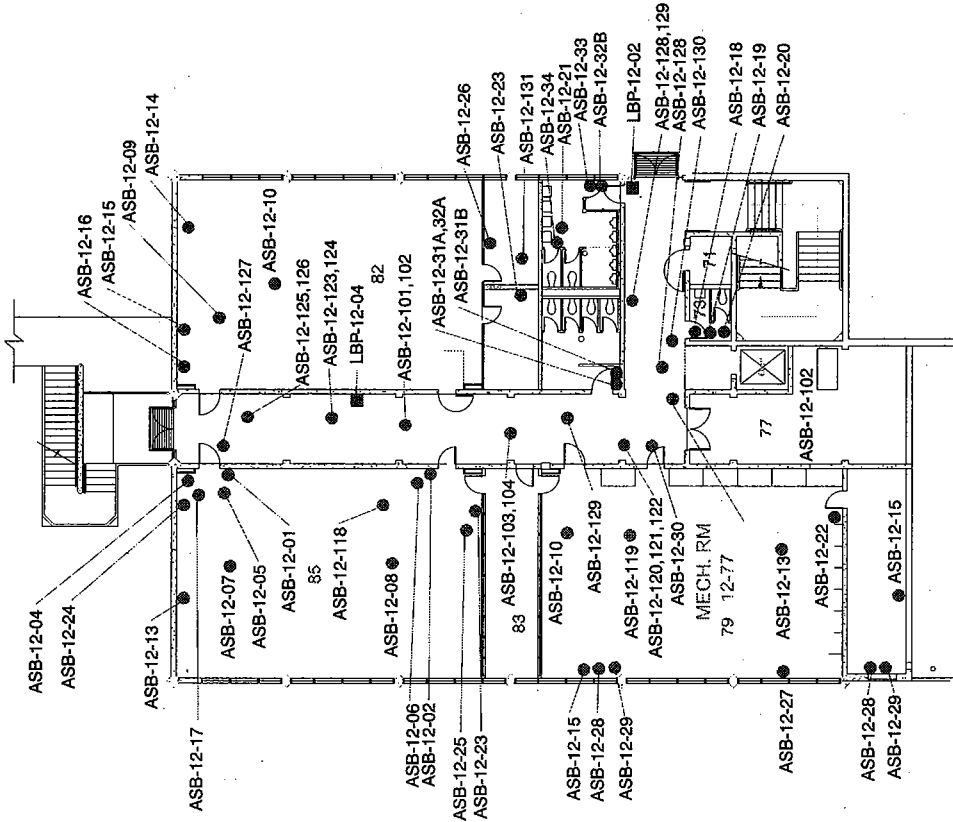
FIGURE 3

ACM/PAINT CHIP SAMPLE LOCATIONS

COLLEGE OF SAN MATEO
CSM-BUILDING 12, GROUND FLOOR
SAN MATEO, CALIFORNIA

Gray Mastic,
1-3% Chrysotile

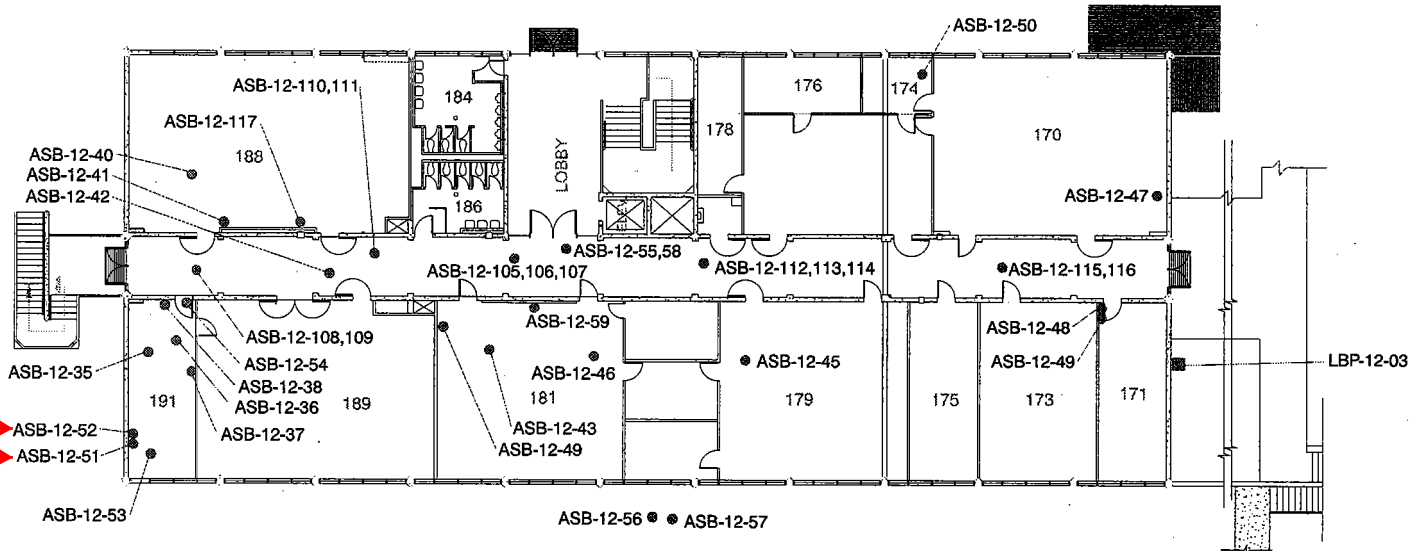
PROJECT NO.	DATE	FIGURE
401256002	10/06	4

ACM/PAINT CHIP SAMPLE LOCATIONS
 COLLEGE OF SAN MATEO
 CSM-BUILDING 12, FIRST FLOOR
 SAN MATEO, CALIFORNIA

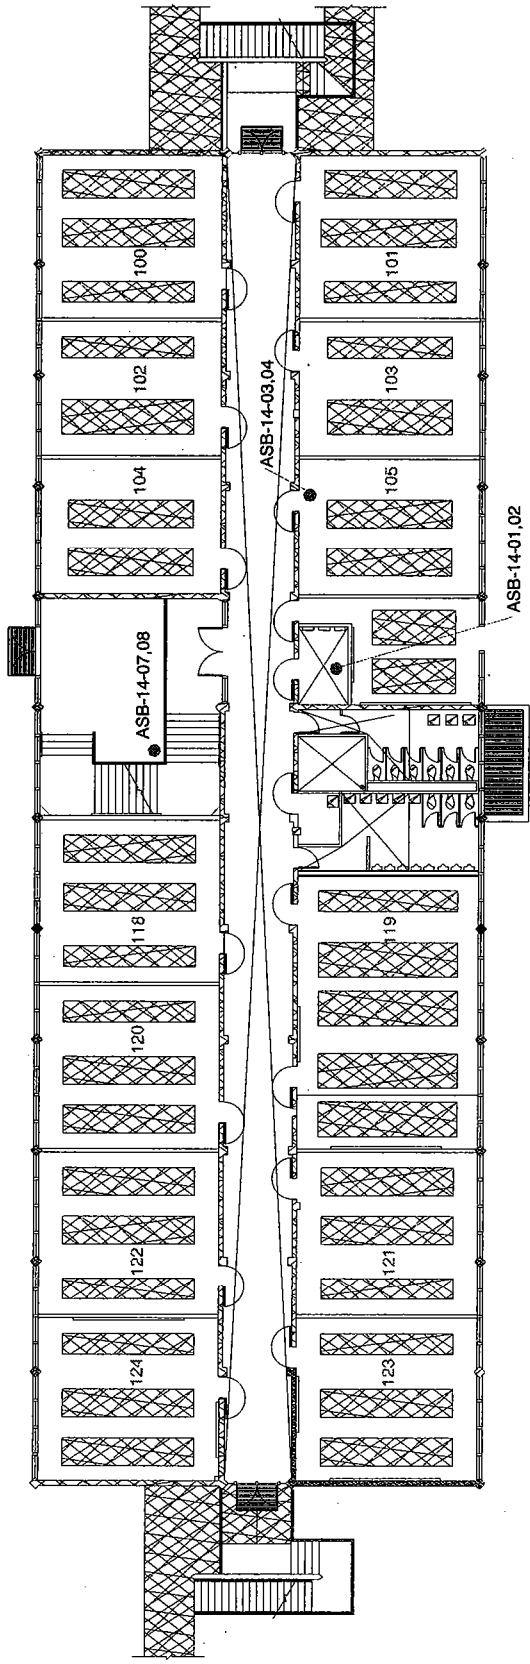
FIGURE
5

ACM SAMPLE LOCATIONS
 COLLEGE OF SAN MATEO
 CSM-BUILDING 14, FIRST FLOOR
 SAN MATEO, CALIFORNIA

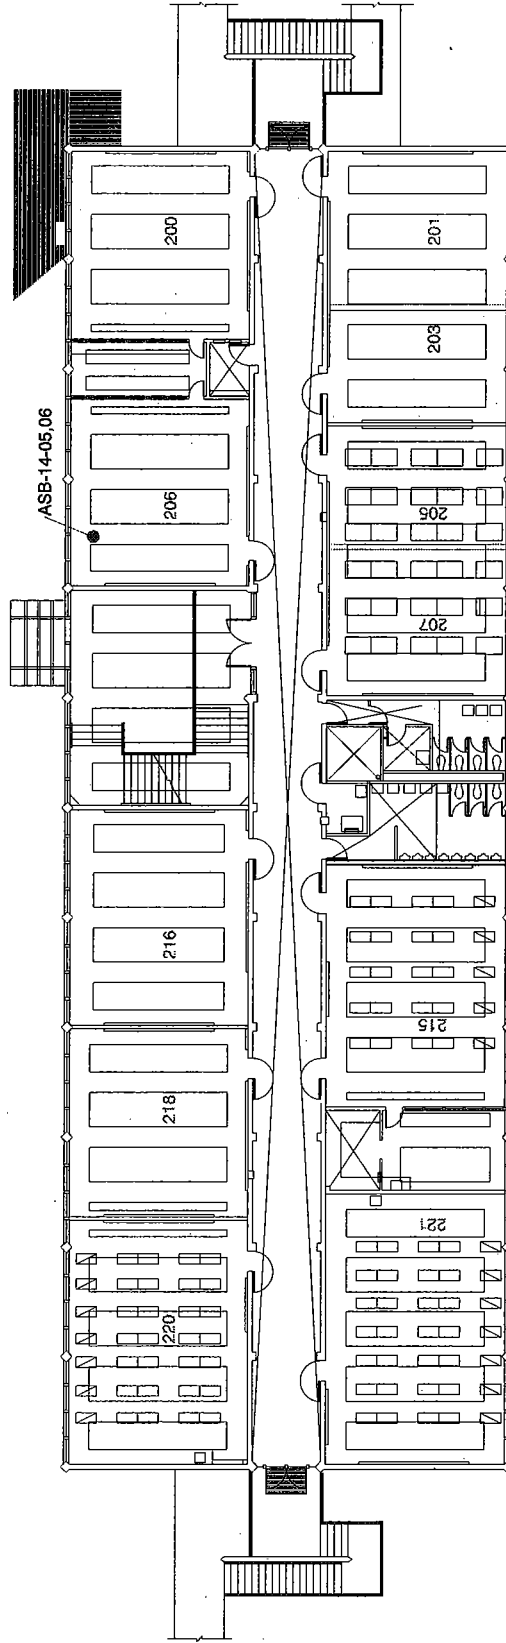
ACH SAMPLE LOCATIONS	
COLLEGE OF SAN MATEO CSM-BUILDING 14, SECOND FLOOR SAN MATEO, CALIFORNIA	
PROJECT NO.	DATE
401256002	10/06
FIGURE 6
