College of San Mateo, Building 9 - 2009 Renovation
HVAC and Temperature Control System Analysis and Preliminary Scope of Repairs
July 19, 2009
developed by GRD Energy

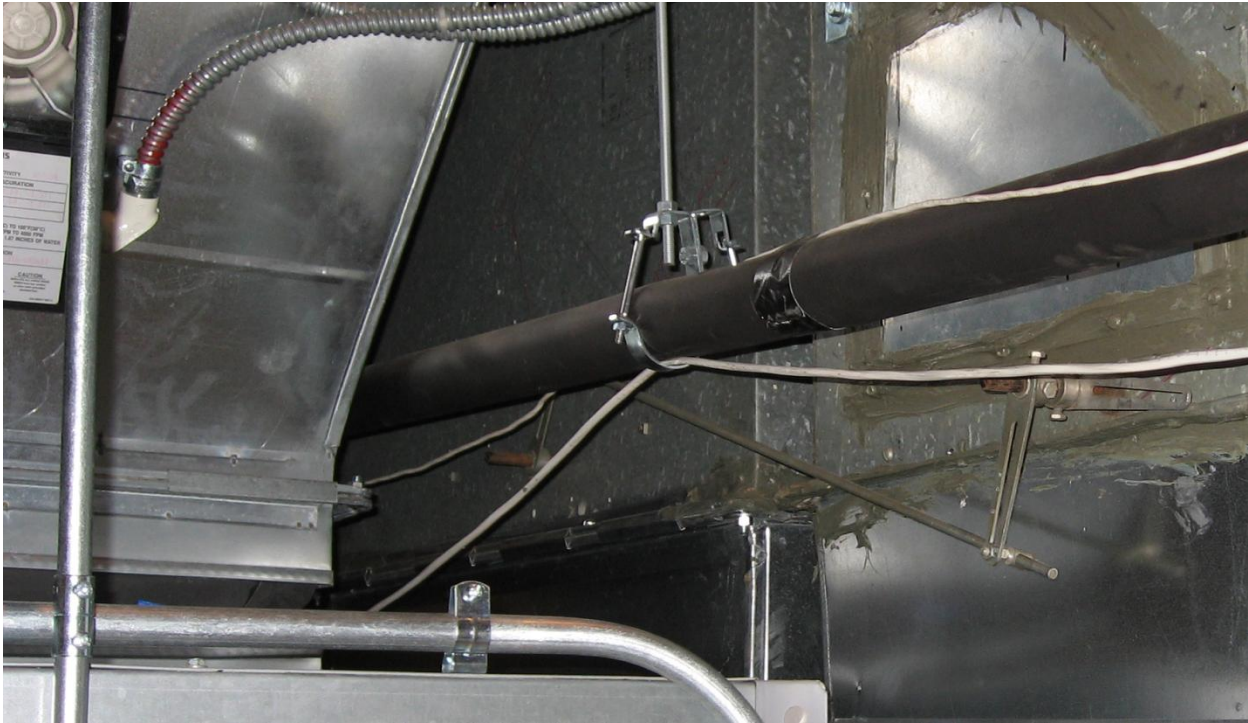
Photo I (AHU-1)

1. AH-1, install economizer actuator(s) for the existing economizer dampers in the ductwork to add an economizer control loop. See picture 1 in Addenda A
2. AH-2, indicates having manual damper, we could not find the dampers. Install new OA and RA dampers or place actuators on existing dampers to add an economizer control loop.
3. FC-5, provide an OA duct to the unit and add and an economizer cycle to the unit.
4. Move the shut off valve for the AHU-1 (Main AHU in basement) further downstream to allow the unit to be shut off without shutting down the main line to the remaining building systems.
5. Replace leaking dielectric unions in the building with a district approved union. Provide a unit price for the replacement of one 1" fitting in ceiling space.
