HAZARDOUS MATERIALS SPECIFICATION

BUILDING 9 & KCSM-FM STUDIO RENOVATIONS

**COLLEGE OF SAN MATEO
1700 HILLSDALE BLVD.
SAN MATEO, CALIFORNIA 94402**

Date: January 22, 2009

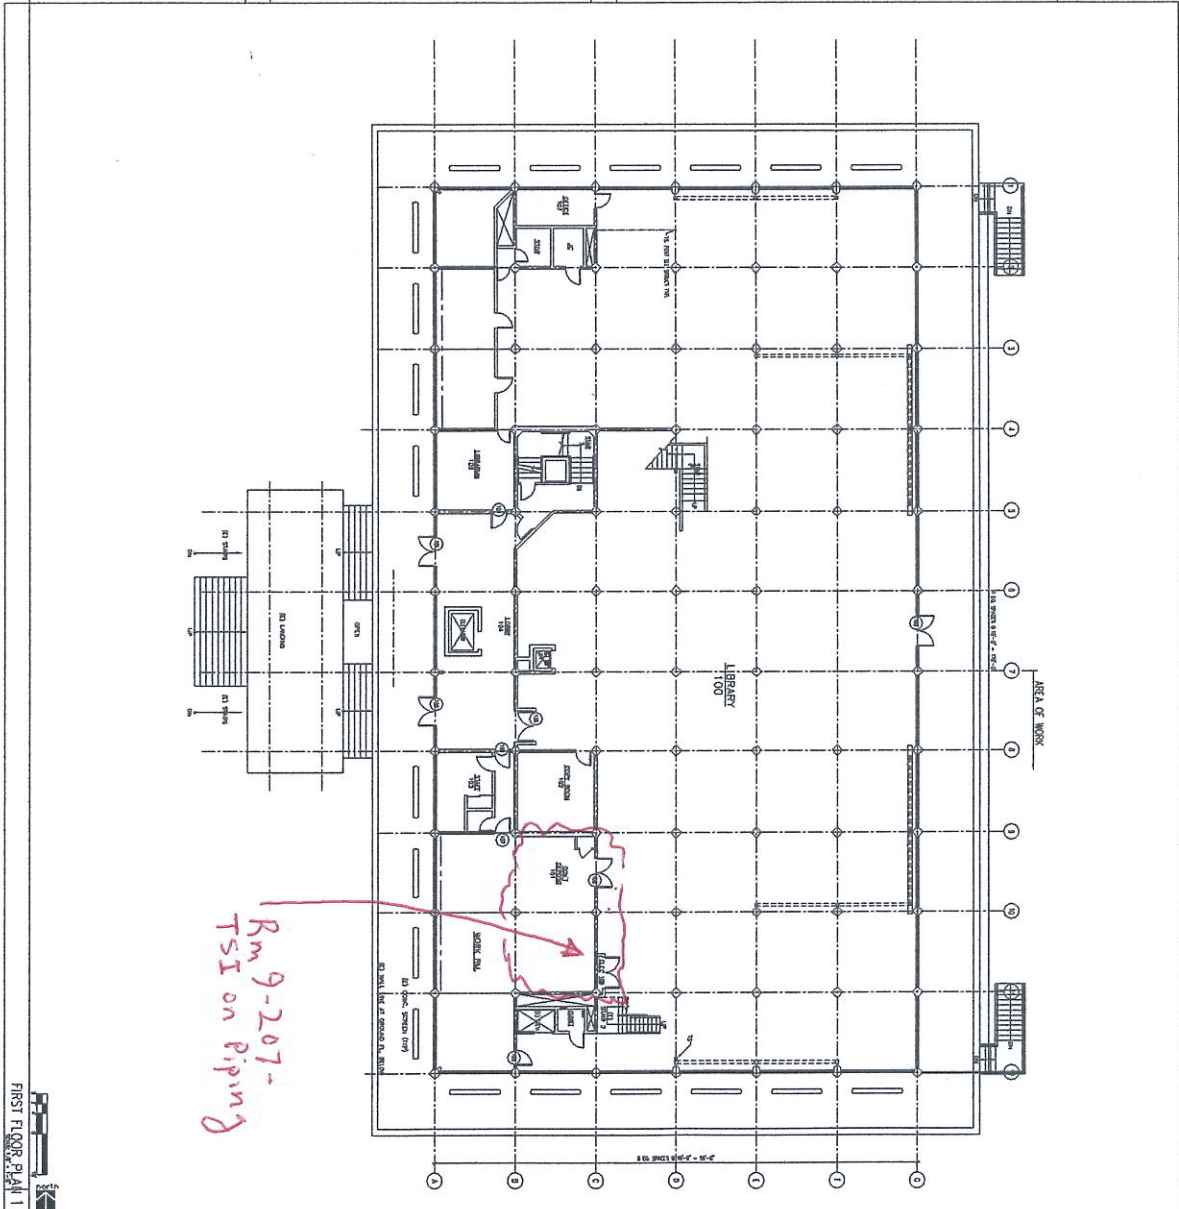
Rm 9-207 -
TSI on Piping
