Building 12 and Colonnades Roof Replacement

San Mateo County Community College 3401 CSM Drive San Mateo, CA 94402

COVER SHEET **GENERAL NOTES AND** INDEX

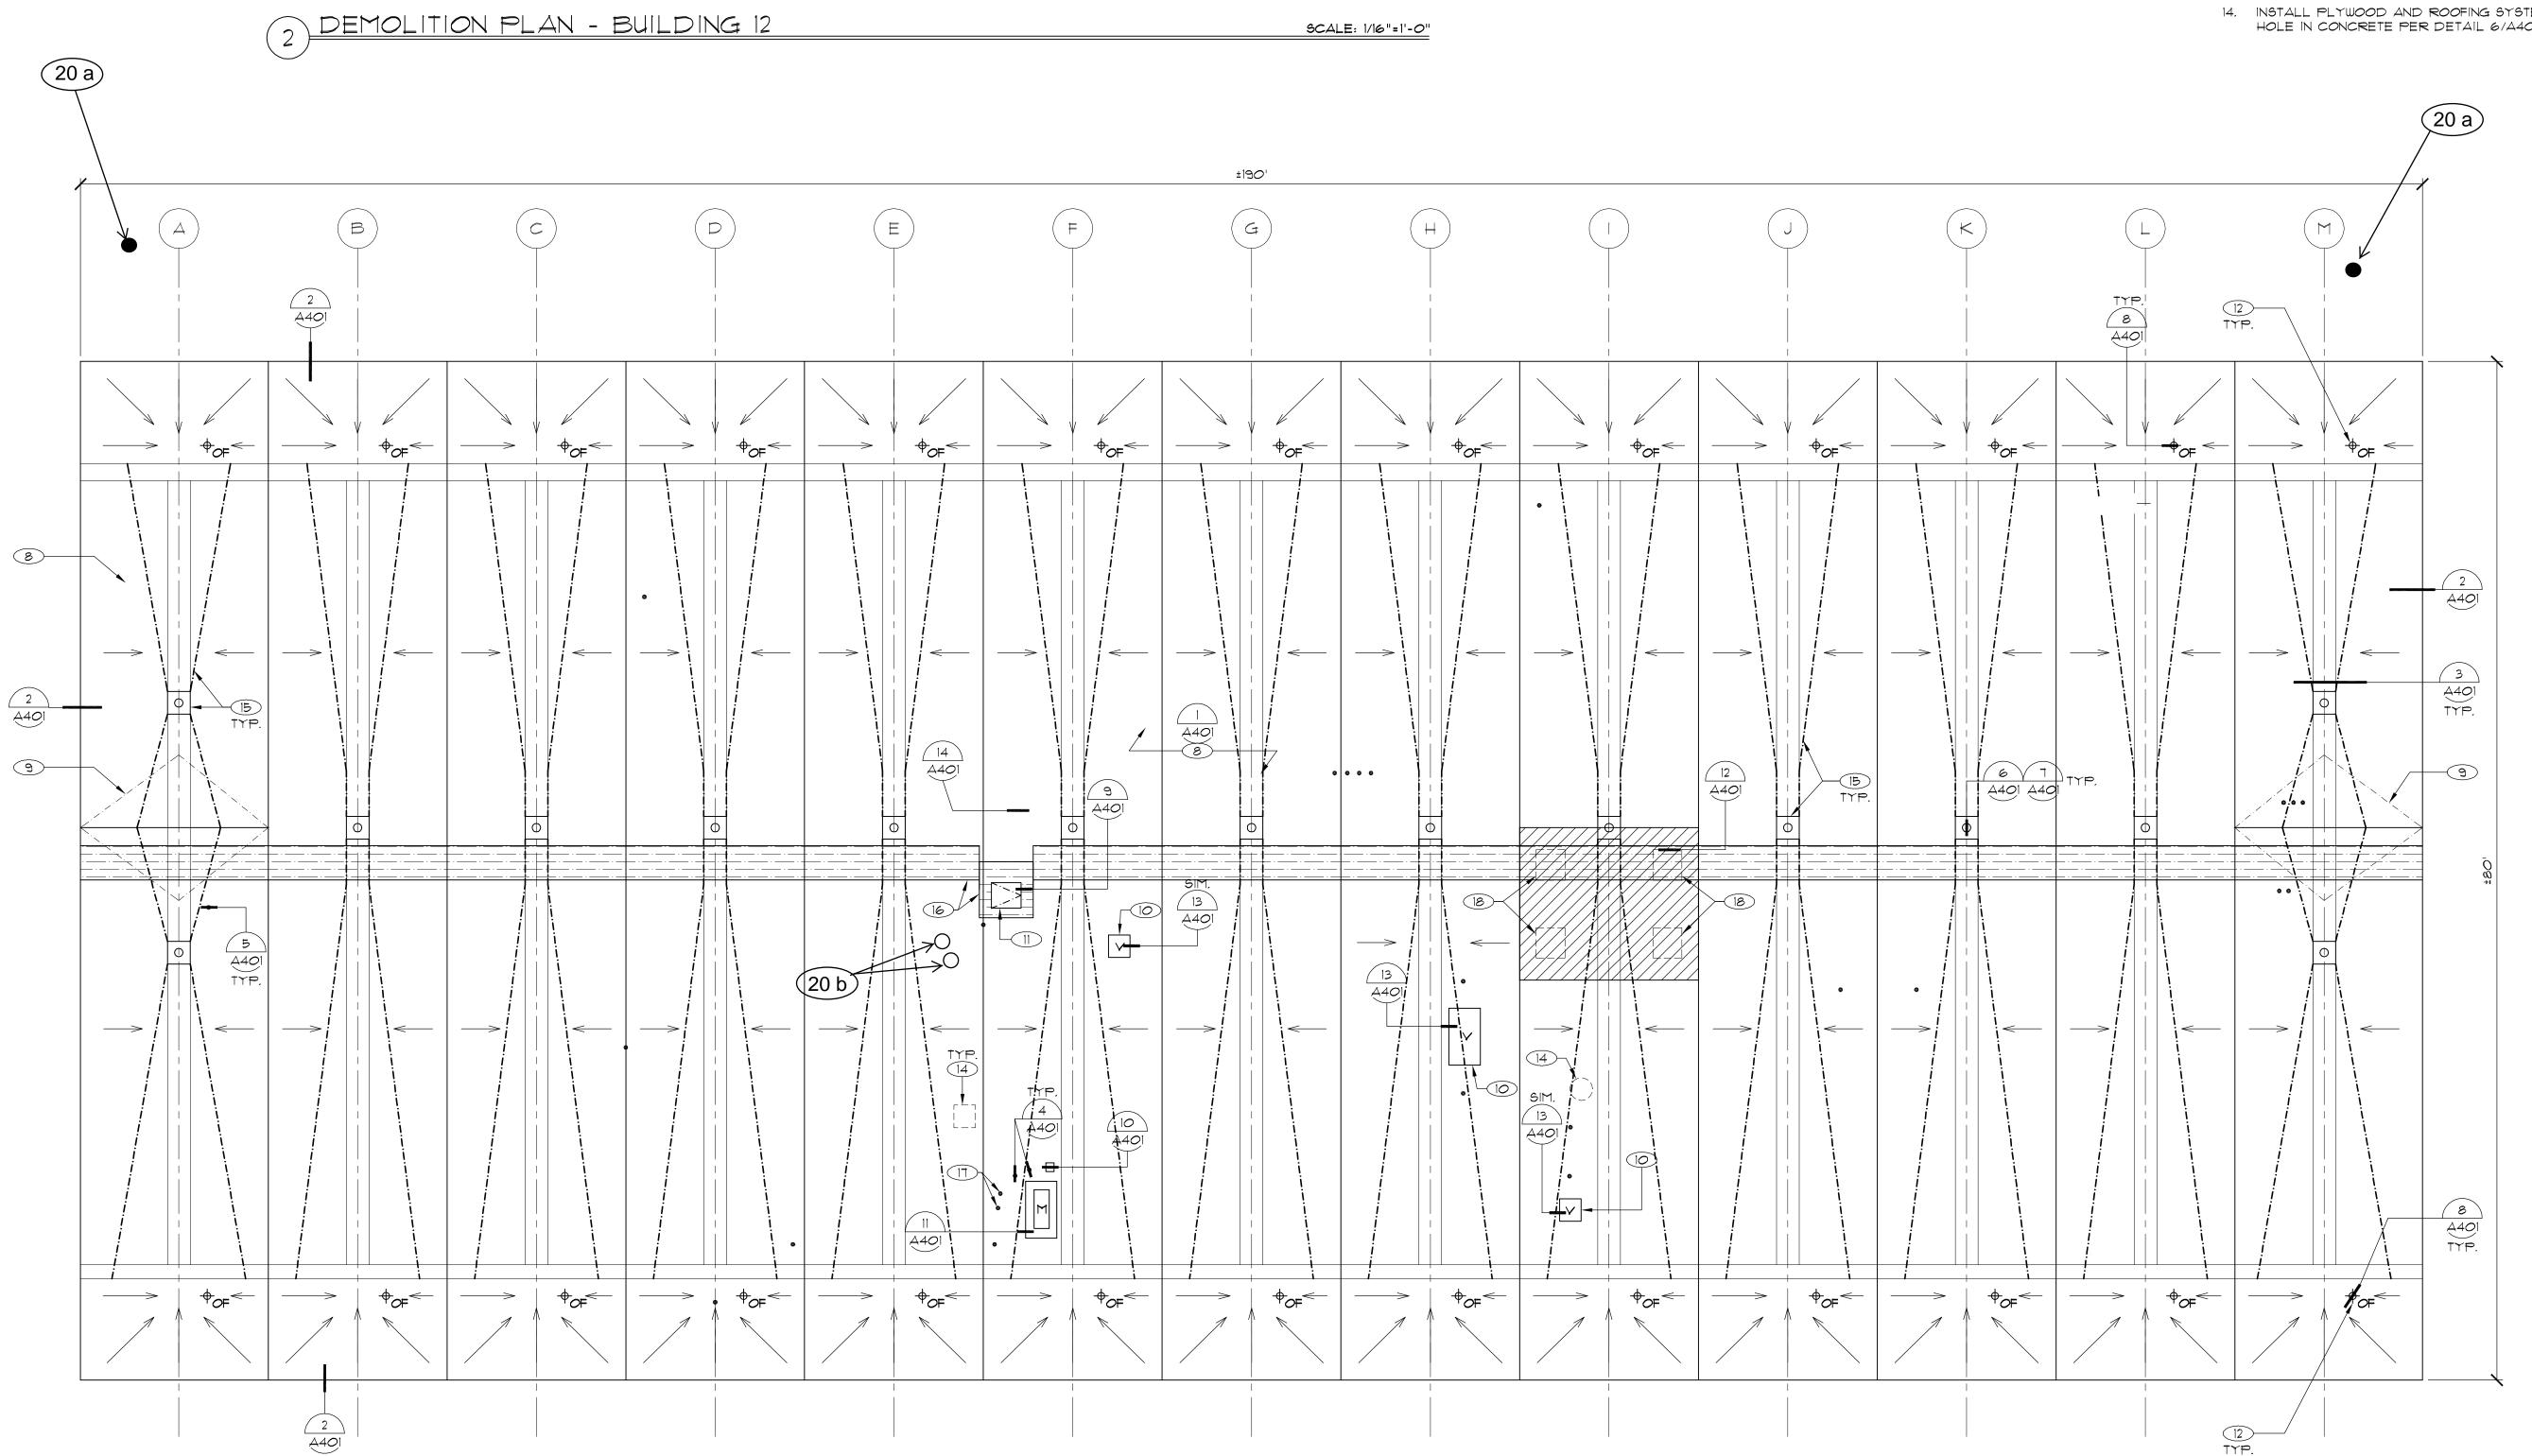
ROOF PLAN - BUILDING 12

- 1. DEMOLISH AND DISPOSE EXISTING GRANULAR SURFACED ASPHALT CAP SHEET BUILT UP ROOF SYSTEM. DEMOLISH AND DISPOSE EXISTING CONCRETE SUPPORT ASSEMBLIES.

- 2. DEMOLISH AND DISPOSE EXISTING MECHANICAL EQUIPMENT AND SCREEN WALL ASSEMBLY. CONCRETE SUBSTRATE TO REMAIN, REFER TO DETAIL7/A402 FOR SUBSTRATE INFILL.

- 3. DEMOLISH AND DISPOSE EXISTING EDGE METAL. DO NOT DAMAGE EXISTING CONCRETE SUBSTRATE.
- 4. DEMOLISH AND DISPOSE EXISTING VENT
- 5. DEMOLISH AND DISPOSE EXISTING ROOF HATCH ASSEMBLY AND LADDER.

- 6. DEMOLISH AND DISPOSE EXISTING FLASHING. DO NOT DAMAGE EXISTING PENETRATIONS.
- 7. DEMOLISH AND DISPOSE EXISTING STRAINER DOME, CLAMPING RING, AND BOLTS.

- 8. PROVIDE 60 MIL FELT BACKED THERMOPLASTIC SINGLE PLY ROOF SYSTEM OVER 1/2" THICK SUBSTRATE BOARD, PRE-PRIMED.
- 9. EXISTING CRICKET TO REMAIN.
- 10. PROVIDE VENT CURB ASSEMBLY WITH ROOFING AND INTEGRATED ARCHITECTURAL HOOD ASSEMBLY.

- II. PROVIDE CAL OSHA APPROVED ROOF HATCH AND LADDER. INSTALL ACCESS LADDER IN THE CUSTODIAL CLOSET ON THE WEST ELEVATION WALL. PROVIDE BRACKETS THAT WILL ACCOMPLISH A 19 INCH STANDOFF THE WALL. PROVIDE BRACKETS AT THE BOTTOM, TOP AND INTERMEDIATE SPAN OF THE LADDER INSTALL LADDER EXTENSION ON THE LADDER. CONTRACTOR TO PROVIDE A WOOD FRAMED PLATFORM FOR ROOF HATCH TO TO SET LEVEL PROVIDE A LEVEL LANDING 3 FEET WIDE AT EXIT POINT FROM ROOF HATCH, REFER TO DETAIL 5/A402. CONTRACTOR TO PROVIDE SHOP DRAWINGS, INCLUDING BRACKETS, FASTENERS, DIMENSIONS, AND CLEARANCES OF LADDER HATCH AND PLATFORM, FOR APPROVAL PRIOR TO INSTALLATION.

- 12. CORE OVERFLOW DRAIN THROUGH (E) CONCRETE SUBSTRATE. SCAN CONCRETE PRIOR TO CORE TO ENSURE (E) RE-BAR IS NOT DAMAGED. INSTALL NEW OVERFLOW PIPE PER DETAIL 8/A401. (TYP.) AT EVERY VALLEY.

- 13. DEMOLISH AND DISPOSE EXISTING VENT ASSEMBLY. CURB TO REMAIN.
- 14. INSTALL PLYWOOD AND ROOFING SYSTEM OVER HOLE IN CONCRETE PER DETAIL 6/A402.

15. WOOD FRAMED CRICKET. FORM 2'-0"x2'-0" SUMP AROUND DRAIN. CONTRACTOR TO SUPPLY CRICKET SHOP DRAWING INCLUDING LAYOUT, SLOPE, SUBSTRATE AND SECUREMENT FOR APPROVAL PRIOR TO INSTALLATION. ALTERNATE: PROVIDE TAPERED POLYISO CRICKETS

ADHERED WITH FOAM ADHESIVE. 16. WALK PAD PATTERN SHOWN TO BE INCLUDED IN BASE BID. CONTRACTOR SHALL ALSO SUPPLY UNIT PRICE PER LINEAR FOOT, FOR ADDITIONAL

- 17. CONTRACTOR TO CORE CONCRETE DECK IN TWO LOCATIONS TO INSTALL TWO 4" CONDUITS FOR FUTURE USE. SECURE WITH 1/2" RISER CLAMP. FLASH INTO ROOF SYSTEM AND CAP OFF TO PROVIDE A WATERTIGHT CONDITION. LOCATION IS APPROXIMATE, VERIFY WITH OWNER PRIOR TO CORING. DETAIL WILL BE SIMILAR TO 4/A401, WITH THREADED CAP INSTALLED.
- 18. INSTALL PLYWOOD AND ROOFING SYSTEM OVER OPEN CURB PER DETAIL 7/A402.
- 19. DEMOLISH AND DISPOSE ABANDONED ELECTRICAL WIRES/CONDUITS BELOW DECK LINE DISCONNECT AND CAP OFF PANEL. WIRES/CONDIUTS BELOW DECK TO REMAIN.

20 a. Provide cant strips, roofing and flashing to waterproof two (2) 18' x 18" base plates that will support security TV cameras.

20 b. Contractor to core concrete deck in two (2) locations and install two (2) 1.5 " conduits for future security TV cameras. Secure with 1/2" riser clamp. Flash into roof system and cap off to provide a watertight condition. Location is approximate, verify with owner prior to coring. detail will be similar to 4/A4.01, with threaded cap installed.

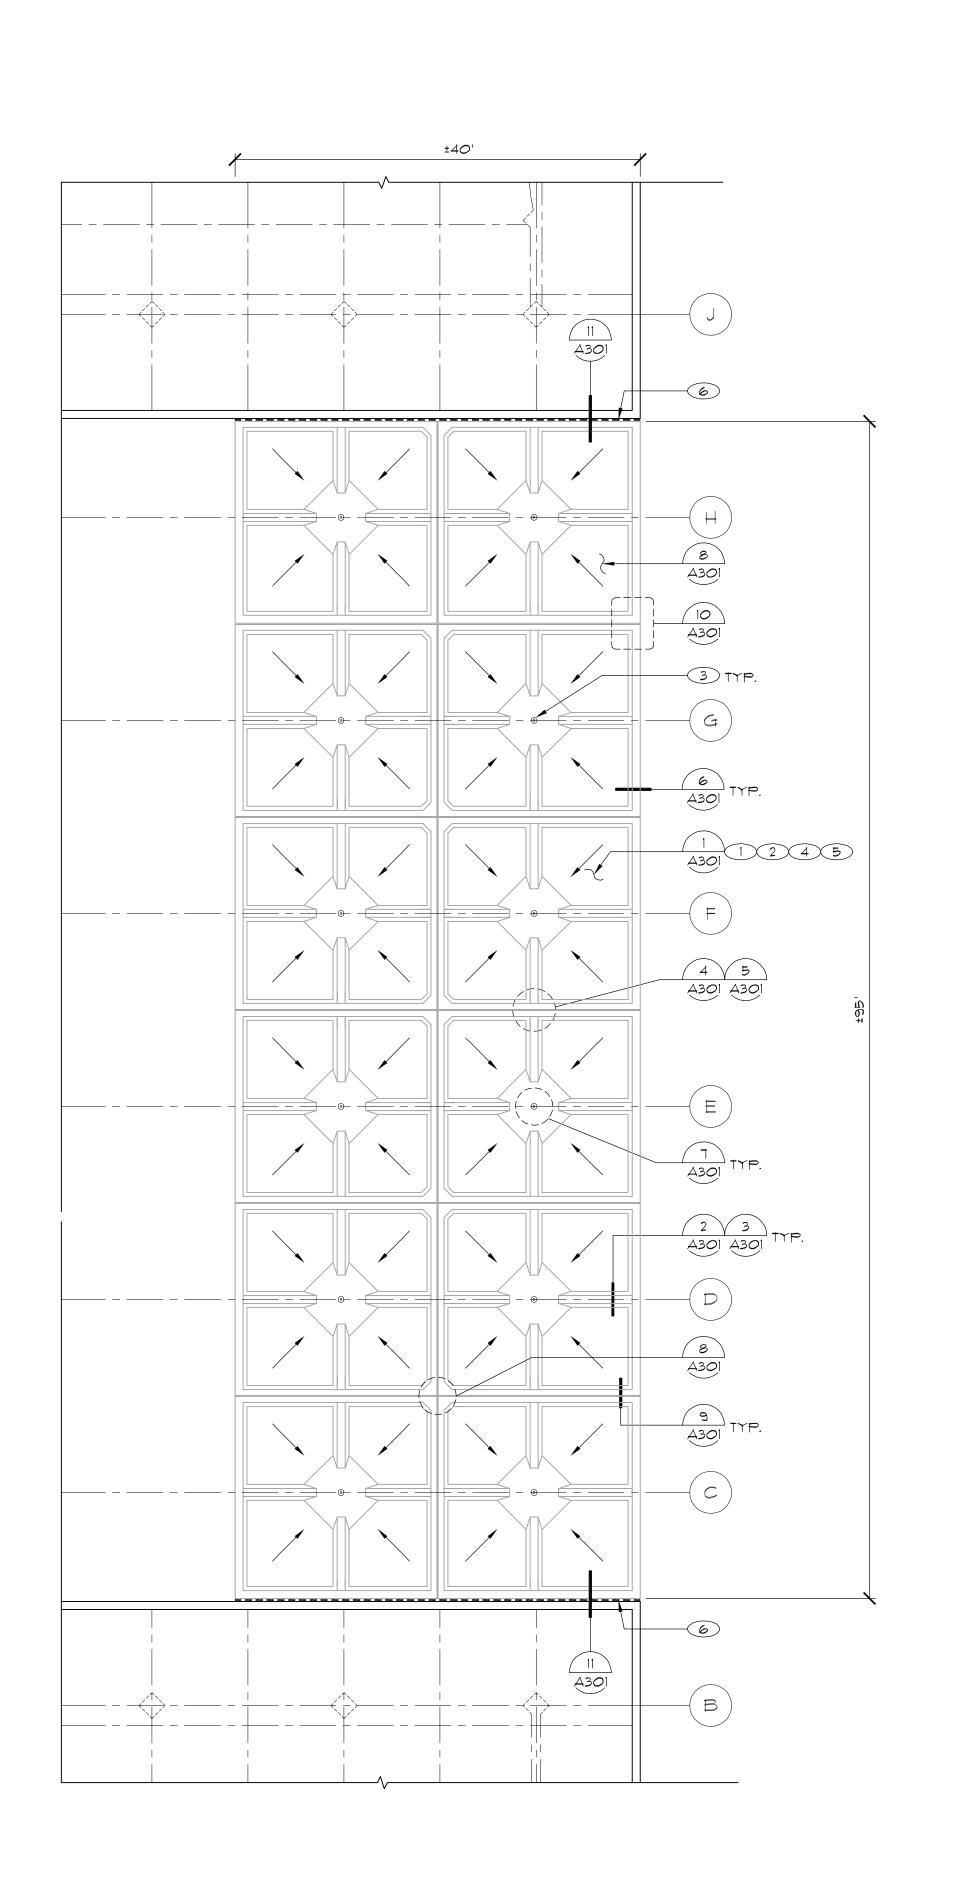
(3) ROOF PLAN -BUILDING 2 AND 4 COLONNADE

4. PROVIDE FLUID-APPLIED ROOFING SYSTEM.5. TYPICAL AT COPPER PENETRATION ADJACENT TO

DRAIN.

6. PROVIDE EXPANSION JOINT, TURN DOWN TO BOTTOM OF FASCIA. PROVIDE PREFABRICATED

EXPANSION JOINT AT ENDS, TYPICAL.

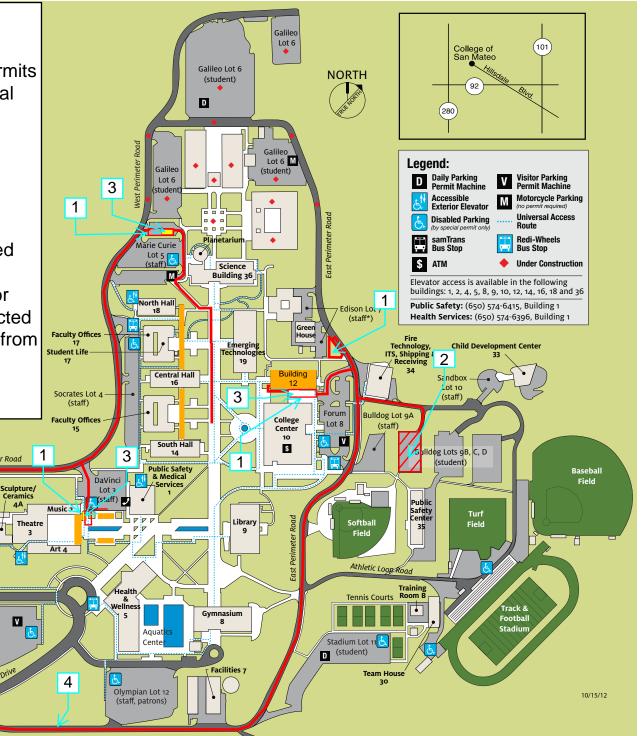
- 1. Equipment and material staging area
- 2. Contractor permit parking (20 parking permits provided by CSM). NO equipment or material staging.
- 3. Trash dumpster

- 4. Contractor access typical
- 5. Areas of Work typical
- 6. B2-4 and B12 may NOT be accessed by vehicle via pedestrian walk paths.
- 7. Colonnades at B14-B18 CAN be accessed via walk paths as shown. Contractor must protect walk paths to prevent any damage or staining. Contractor vehicles must be inspected and maintained to prevent any oils or fluids from staining concrete walk paths.
