**To:** Mr. Drew Bagdasarian  
**Company:** SMCCCD c/o DRB Associates  
**Address:** 220 Montgomery Street, Suite 1830  
San Francisco, California 94104  
**Cc:**  
**Project:** Cañada College Electrical Infrastructure  
Replacement Project  
**Project No.:** 177-1-7

<b>TYPE OF SERVICES</b>	Geotechnical Investigation and Geologic Hazards Evaluation
<b>PROJECT NAME</b>	Canada College Electrical Infrastructure Replacement
<b>LOCATION</b>	4200 Farm Hill Road Redwood City, California
<b>CLIENT</b>	San Mateo County Community College District
<b>PROJECT NUMBER</b>	177-1-7
<b>DATE</b>	April 23, 2010

<b>Type of Services</b>	<b>Geotechnical Investigation and Geologic Hazards Evaluation</b>
<b>Project Name</b>	<b>Cañada College Electrical Infrastructure Replacement</b>
<b>Location</b>	<b>4200 Farm Hill Road Redwood City, California</b>
<b>Client</b>	<b>San Mateo County Community College District</b>
<b>Client Address</b>	<b>2700 West Hillsdale Boulevard, Building 27 San Mateo, California</b>
<b>Project Number</b>	<b>177-1-7</b>
<b>Date</b>	<b>April 23, 2010</b>

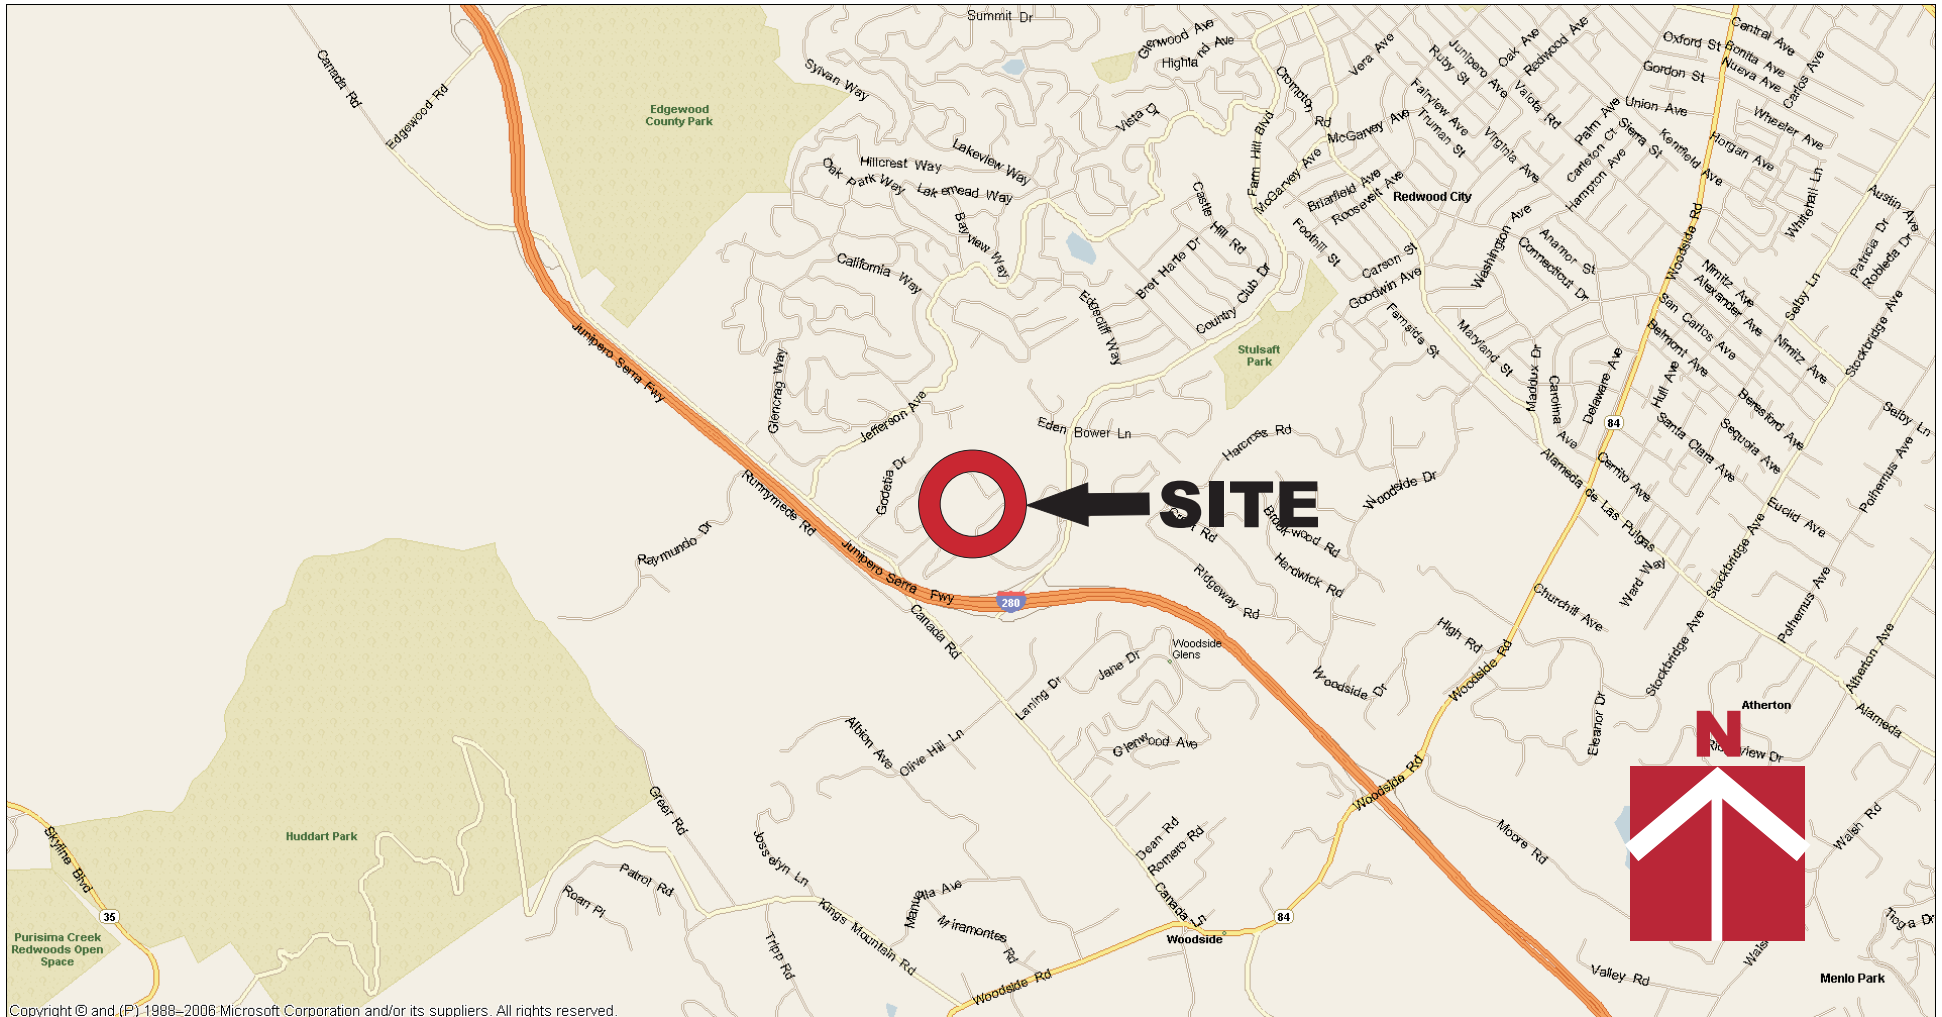
This report has been prepared for the sole use of the San Mateo County Community College District for the proposed Cañada College Electrical Infrastructure Replacement project. The location of the site is shown on the Vicinity Map, Figure 1.

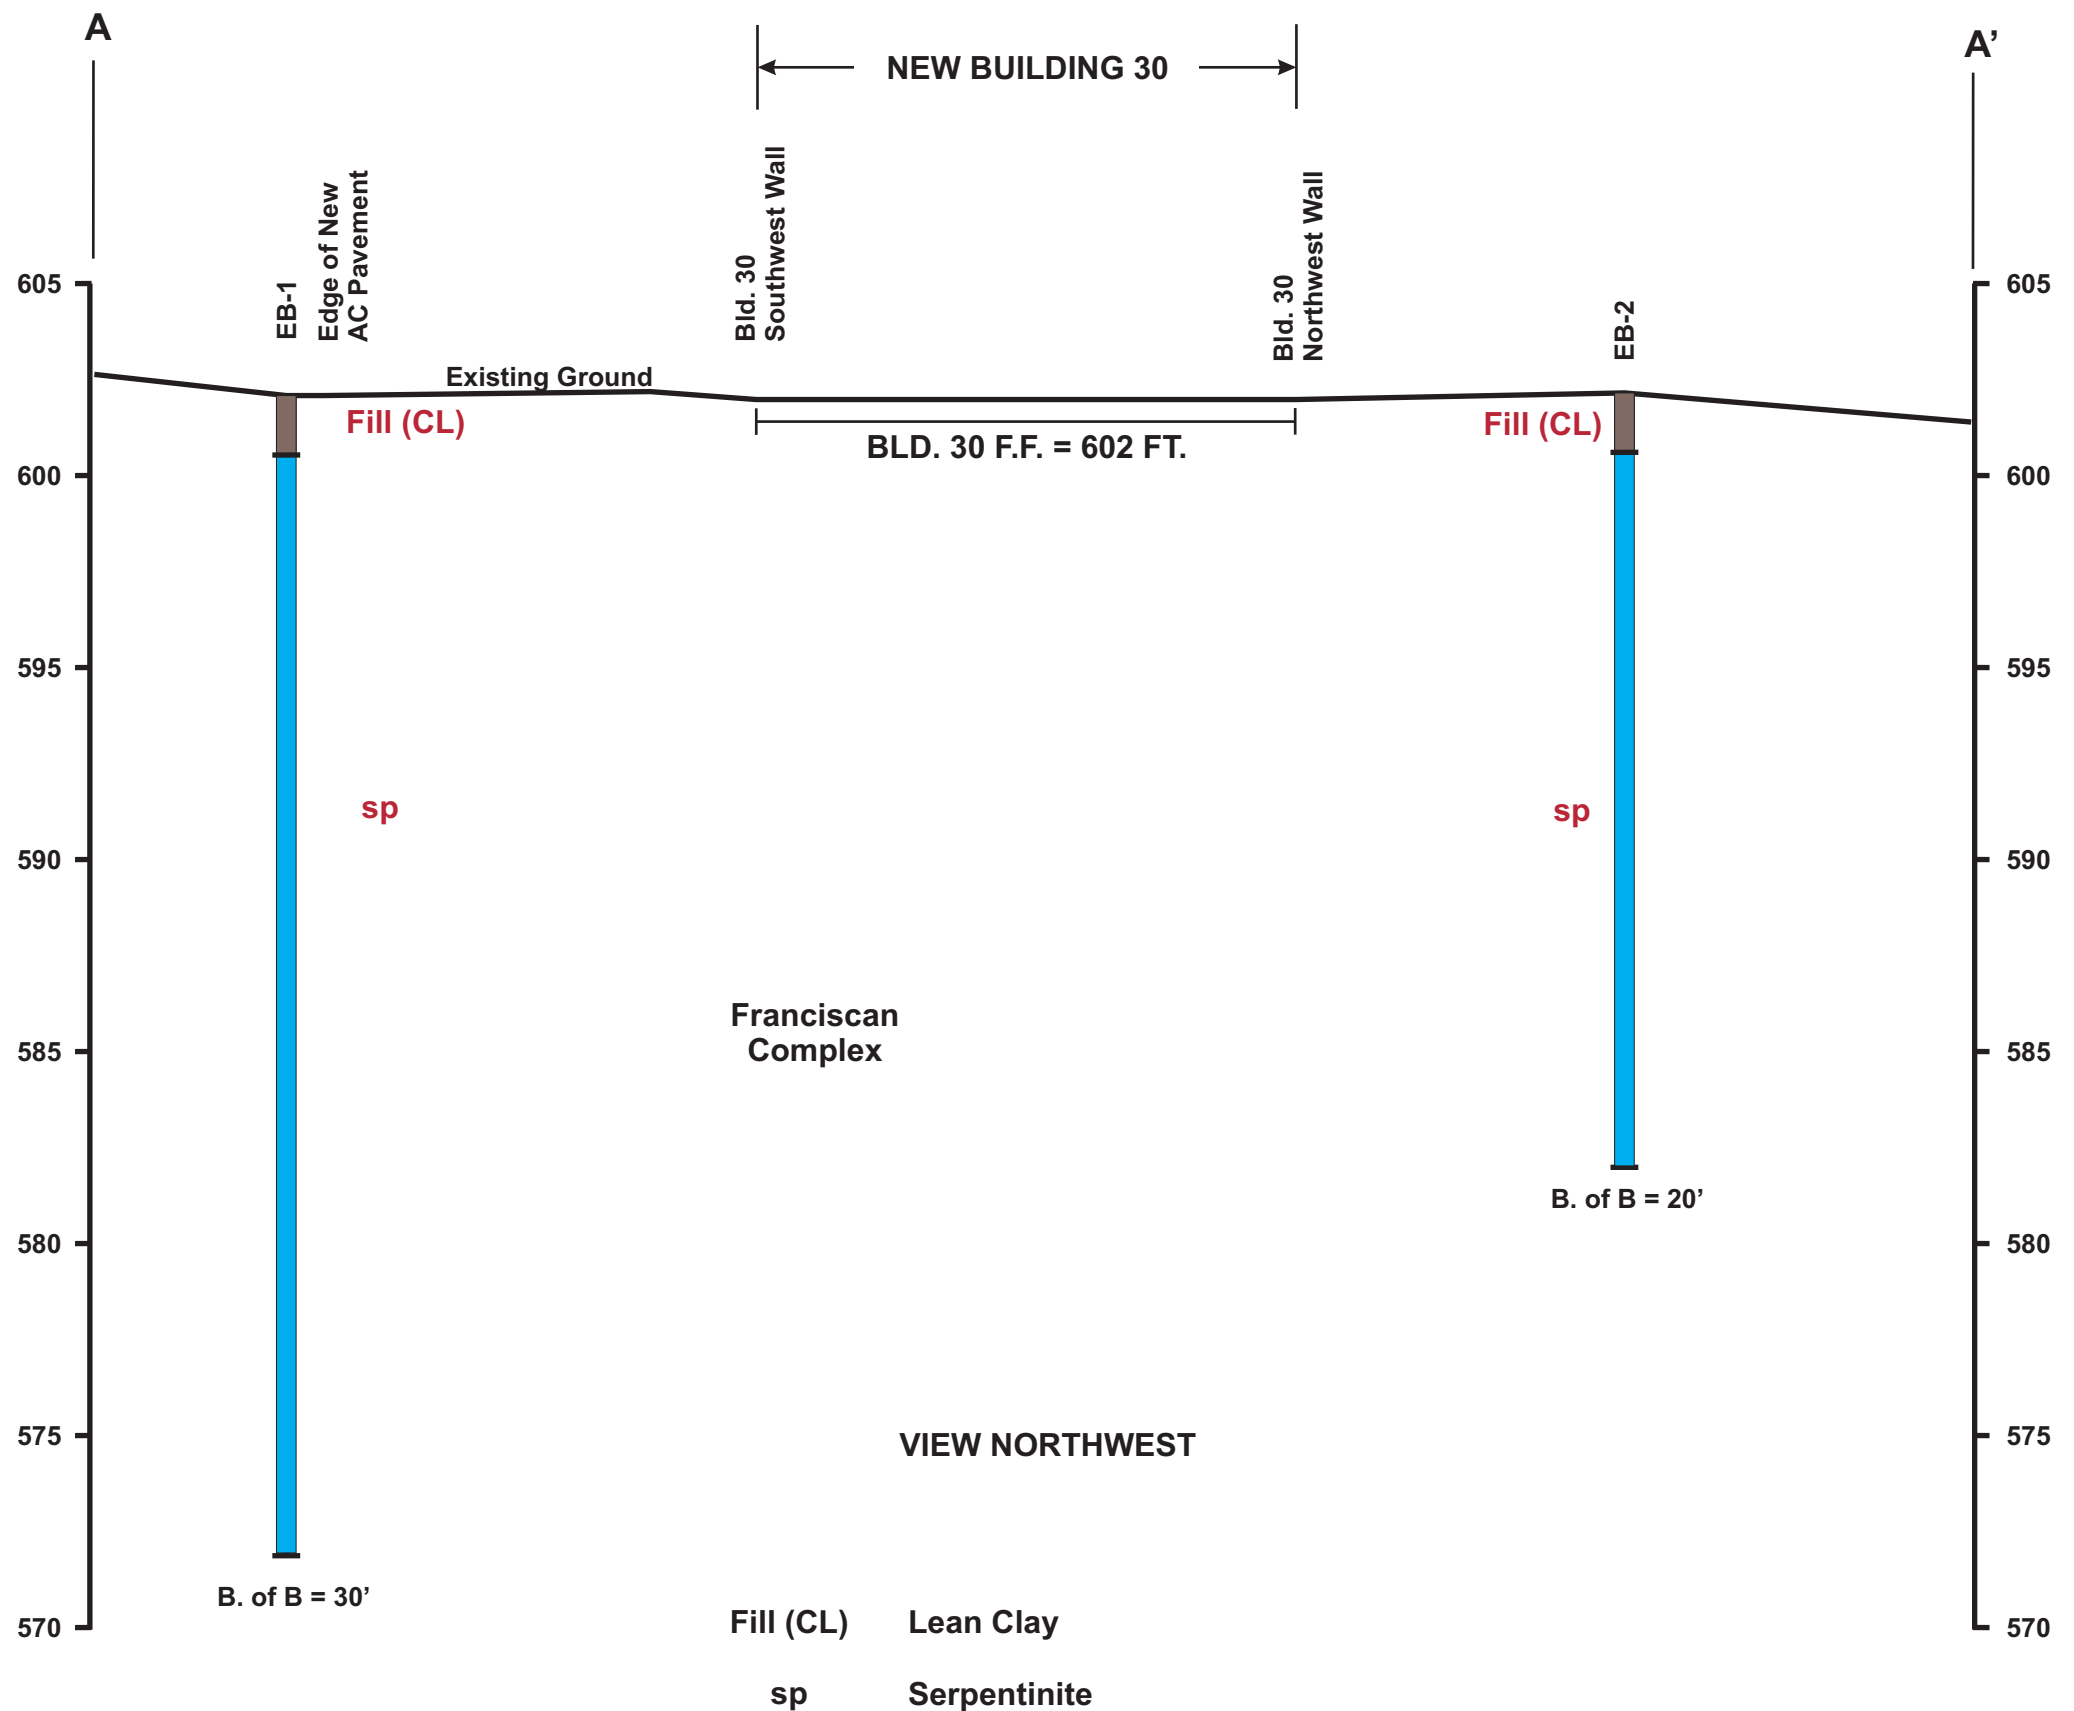
<b>Geologic Cross Section A-A'</b>	
	Project Number 177-1-7	Figure Number Figure 6
Date April 2010		Drawn By MGV

See Figure 2A for location of cross-section.

SCALE: 1" = 5'  
 Vertical & Horizontal

A geologic cross-section, Figure 6, illustrates the generalized subsurface conditions within the new Building 30 site location.

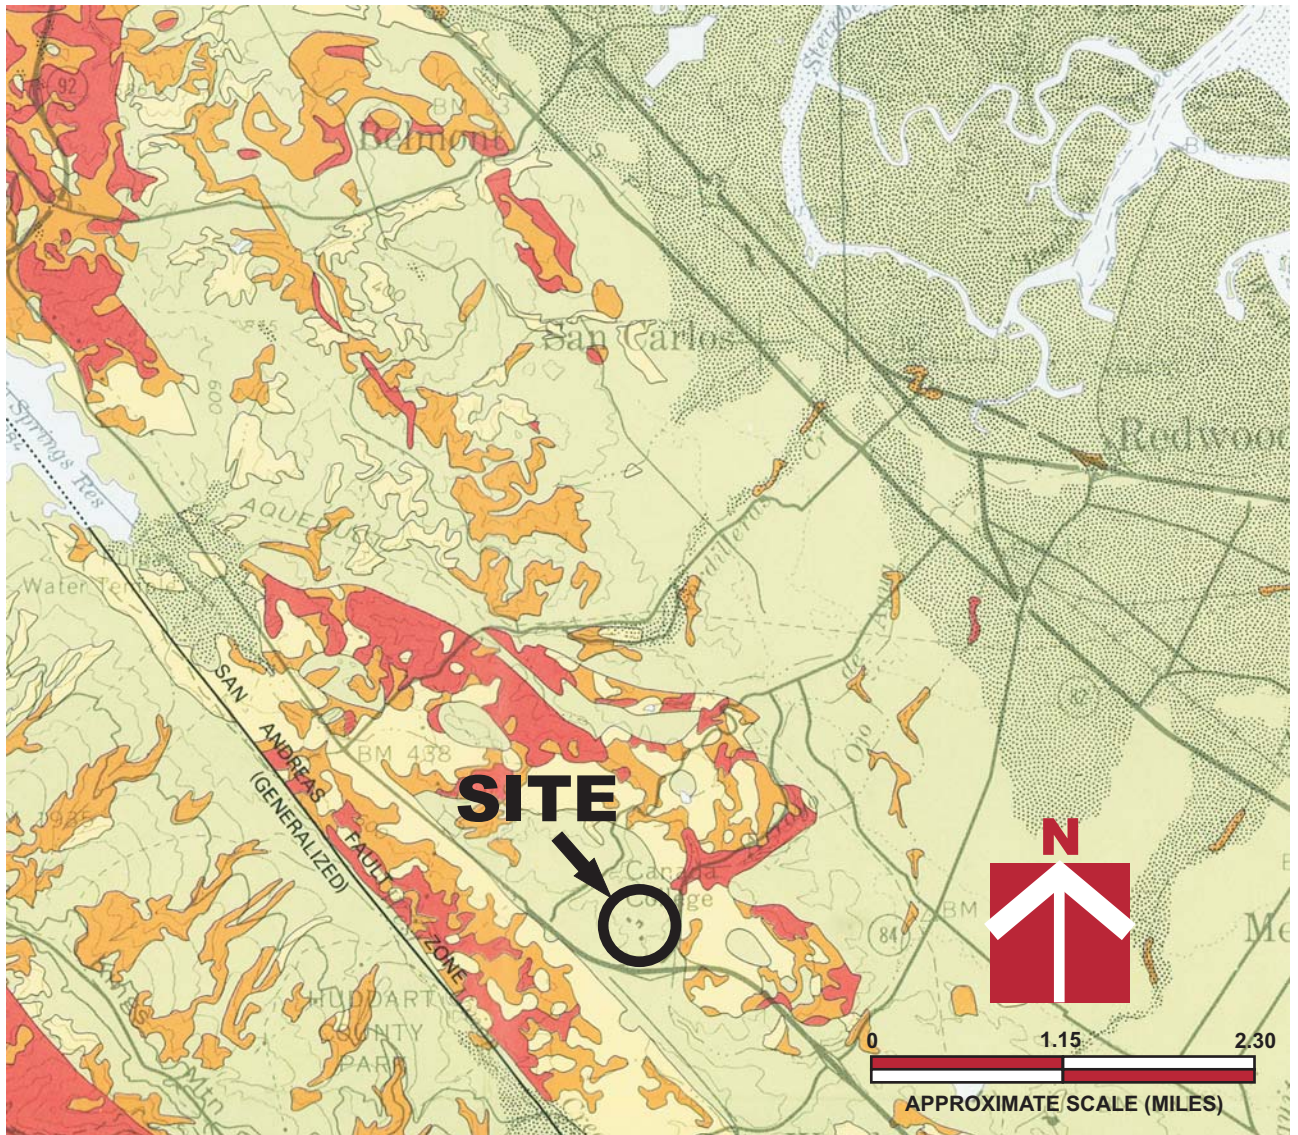
**EXPLANATION**

- Susceptibility and percentage of area likely to fail in a major earthquake
- High* ----- less than or equal to 25%
  - Moderate* ----- approximately 15%
  - Low* ----- approximately 5%
  - Very low* ----- less than 3%
- AREA OF LOW, MODERATE, OR HIGH LIQUEFACTION SUSCEPTIBILITY—Data from T. L. Youd and J. B. Perkins (1985)
- FAULT ZONE—Approximately located. Data modified from Brabb and Pampeyan (1983). Specific location generalized, therefore should not be used for evaluation of fault-rupture hazard

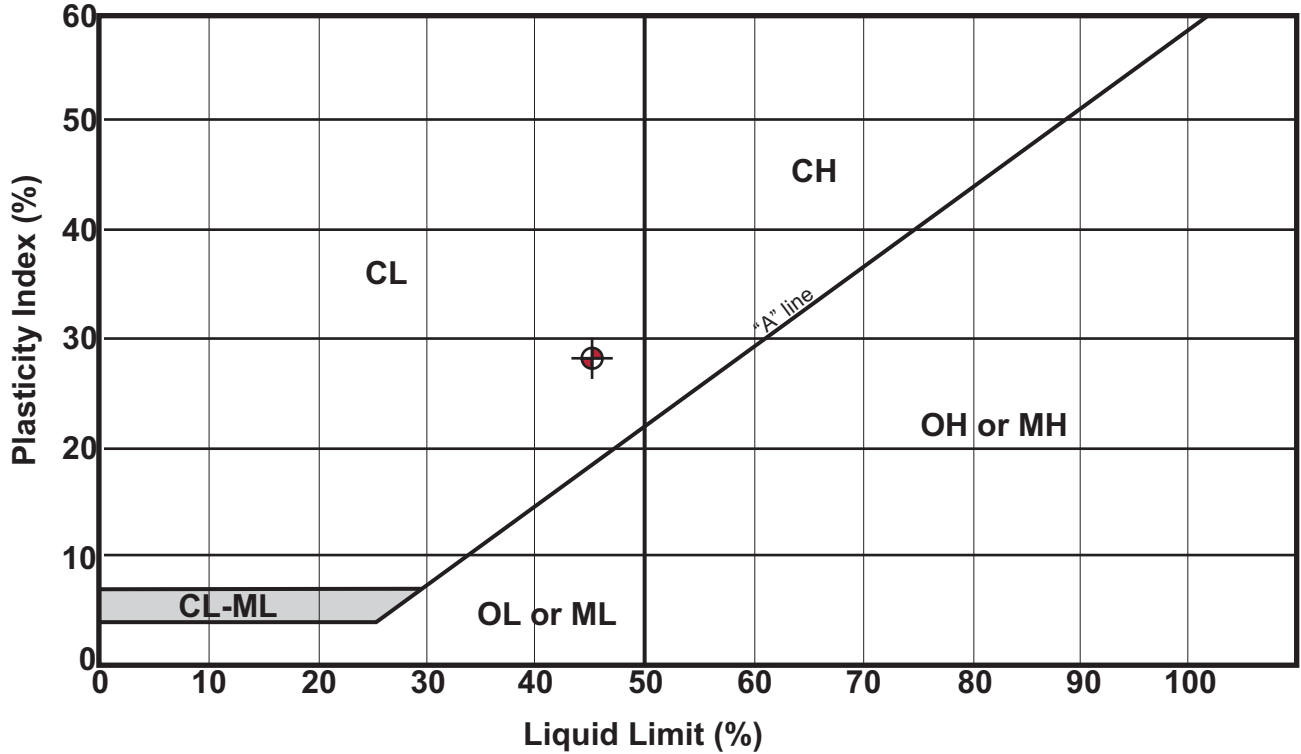
### Plasticity Index (ASTM D4318) Testing Summary

Symbol	Boring No.	Depth (ft)	Natural Water Content (%)	Liquid Limit (%)	Plastic Limit (%)	Plasticity Index	Passing No. 200 (%)	Group Name (USCS - ASTM D2487)
⊕	EB-2	3.5	17	45	17	28		Serpentinite [sp]

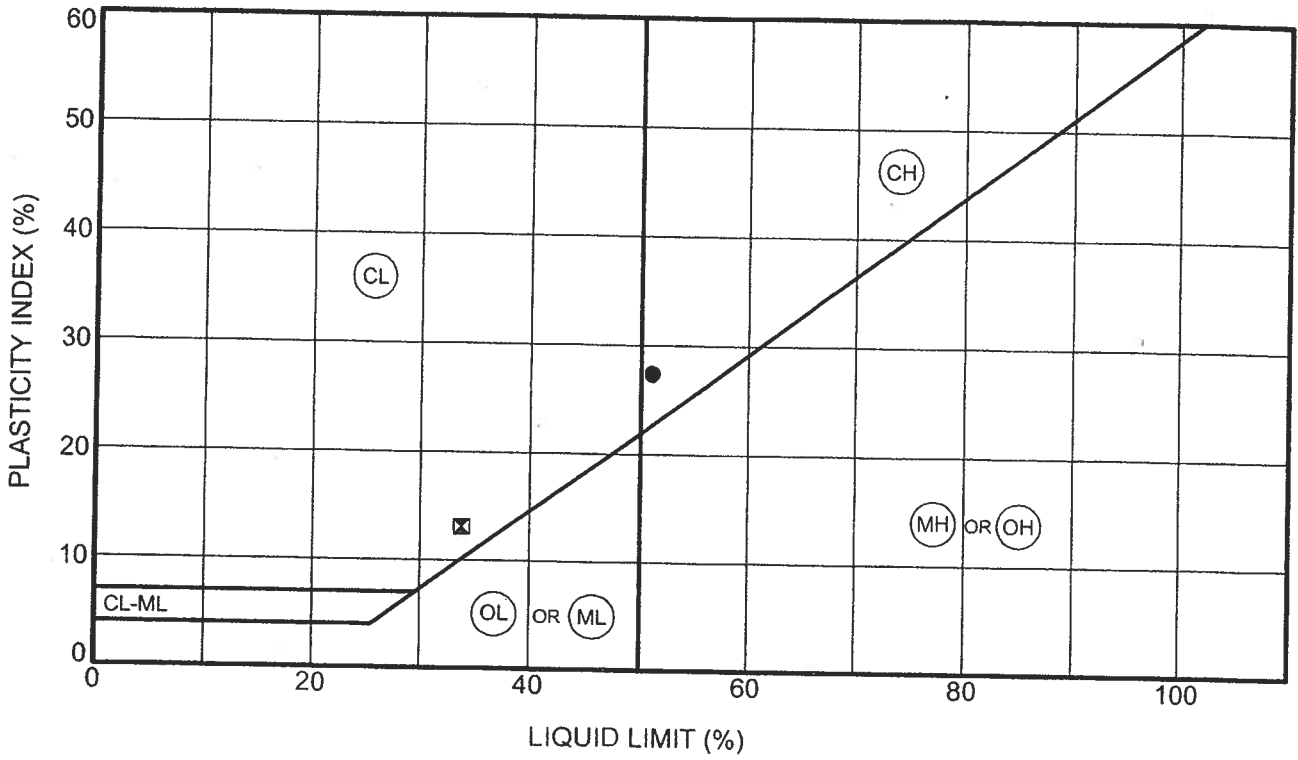
Symbol	Boring No.	Depth (ft.)	Natural Water Content (%)	Liquid Limit (%)	Plastic Limit (%)	Plasticity Index (%)	Passing No. 200 Sieve	Unified Soil Classification Description
●	EB-2	0.3		51	24	27		FAT CLAY WITH SAND (CH)
⊠	EB-3	2.0	14	34	21	13		CLAYEY SAND (SC)

**Plasticity Index:** Plasticity Index determinations (ASTM D4318) were performed on two samples of the subsurface soils to measure the range of water contents over which these materials exhibit plasticity. The Plasticity Index was used to classify the soil in accordance with the Unified Soil Classification System and to evaluate the soil expansion potential. Results of these tests are presented on Figure B-1 and on the logs of the borings at the appropriate sample depths.
